TECHNICAL REPORT TR 3081
October 2017

**Comprehensive Field Surveys and Evaluation
of Biofouling and Coating System Conditions
Associated with the Hull of the
ex-USS INDEPENDENCE (CV 62)**

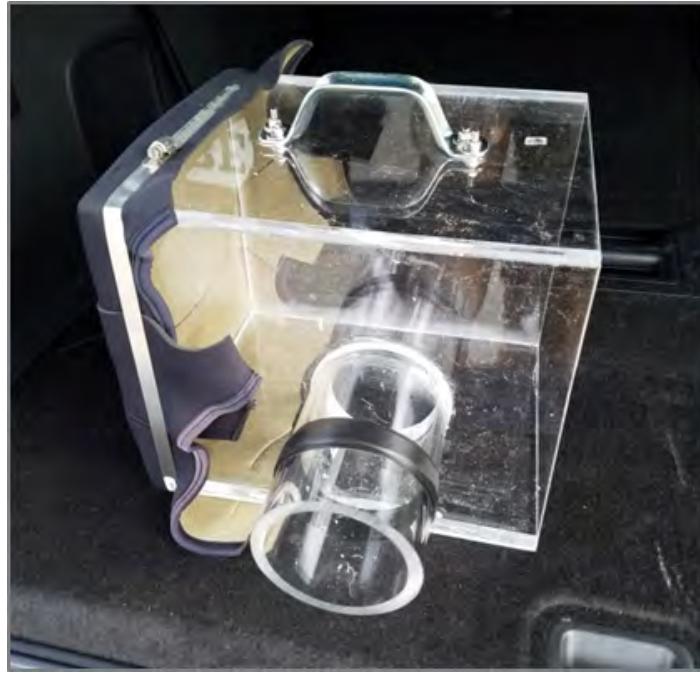
Figure 2. Biological specimen sample device.

A 0.25 square meter (m^2) (0.25 by 0.25 m) Plexiglas sampling box was constructed with an open end that was placed against the hull for collection of biological samples used for both biomass and taxonomy assessments. The opposite end of the box was covered with neoprene with a slit allowing access to the inside of the box. On the bottom of the box was a tube facilitating collection of the sample down into a tightly woven white cotton cloth sample bag that was attached on the outside of the tube (Figure 2). The sample bag had a mesh of 200 micron (μm) and was 14 inches (in) 35.6 centimeter (cm) long with a 4-in (10.2 cm) opening. A diver placed the open end of the sampling box firmly against the hull of the ship to prevent loss of any biota sampled. A second diver inserted a scraper into the neoprene slit and scraped biota from the hull, ensuring all of the specimens were collected in the cloth sampling bag. Motile fauna were also captured if they were located within the quadrat. The bag was then closed off and secured with a zip-tie to prevent loss of the biota sample. For several sampling stations, additional sample bags were used if necessary. The fouling density required the scientific diver to remove some of the biota prior to placement of the sampling box to ensure it was flush against the hull. Biota removed pre placement of the box was also collected in bags. Each bag was numbered prior to commencement of diving operations and those numbers were communicated to topside scientists for accurate recordkeeping. After biota were collected and secured in sample bags, the bags were stored in a large tool bag and returned to the surface. During the survey, in some instances, video was recorded to gather more information. Upon retrieval at the surface, all bags were immediately transferred and samples were prepared for laboratory analysis.

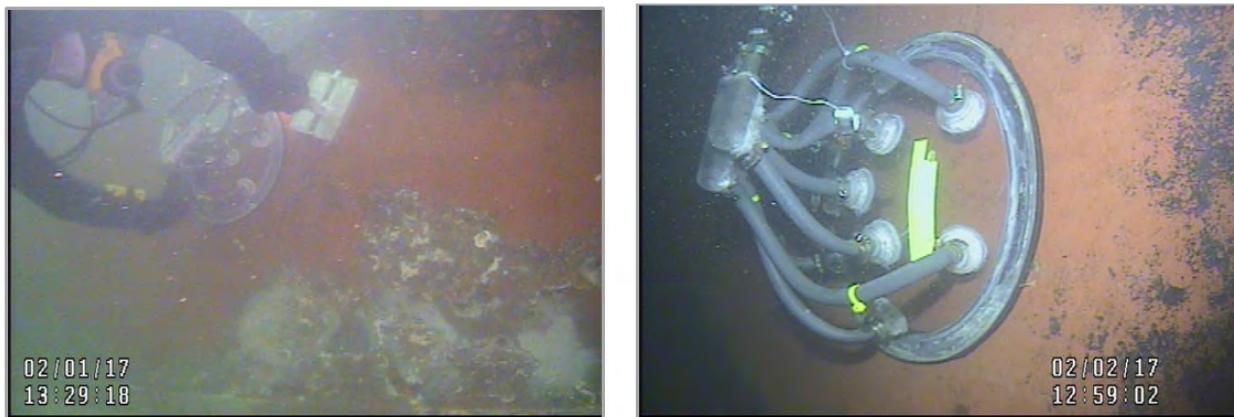
Figure 7. Dome placement on the hull of the ex-INDEPENDENCE post hull cleaning.

were withdrawn from the dome at 0, 15, 30, 45, and 60 minutes (min). Approximately 30 mL of each sample were filtered through a 0.45 μm disc filter, representing the dissolved fraction. Three dome sampling events were completed. On 13 December 2016, there was a single deployment for conditions pre-hull cleaning. Four dome deployments on uncleaned surfaces were accomplished on 11 January 2017, one week post hull cleaning started. The final dome sampling event ($n = 12$) was conducted on the 1-2 February 2017, with conditions representative of a recently cleaned hull surface.

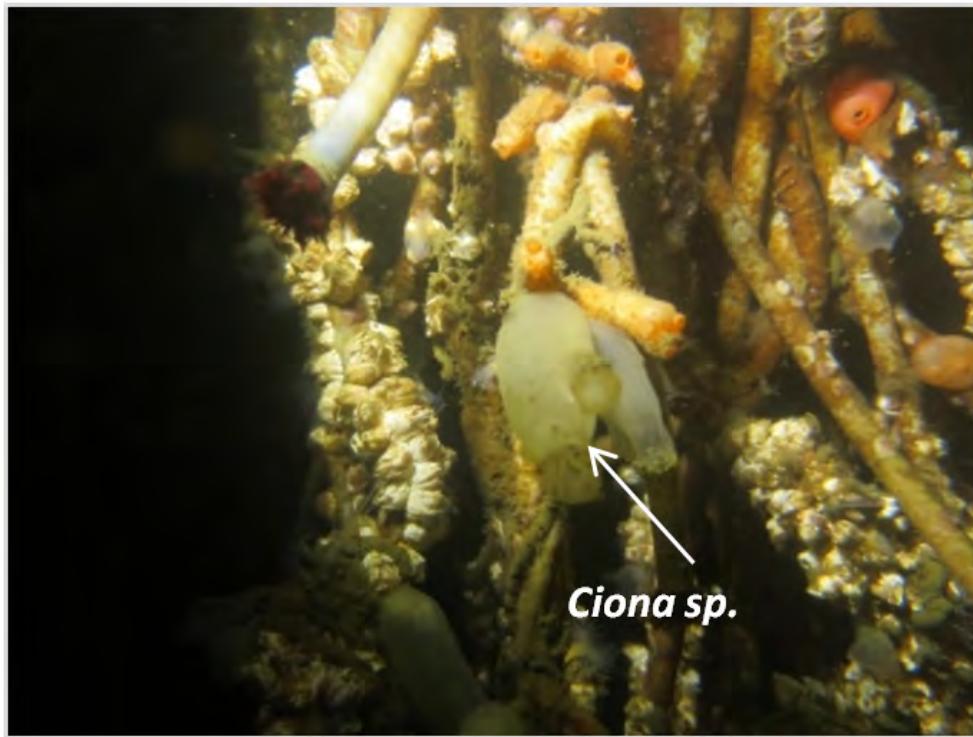
Figure 13. Characteristic density of biofouling in some areas on the hull of the ex-INDEPENDENCE observed during pre-hull cleaning inspections. The high-risk species *Ciona sp.* is noted.

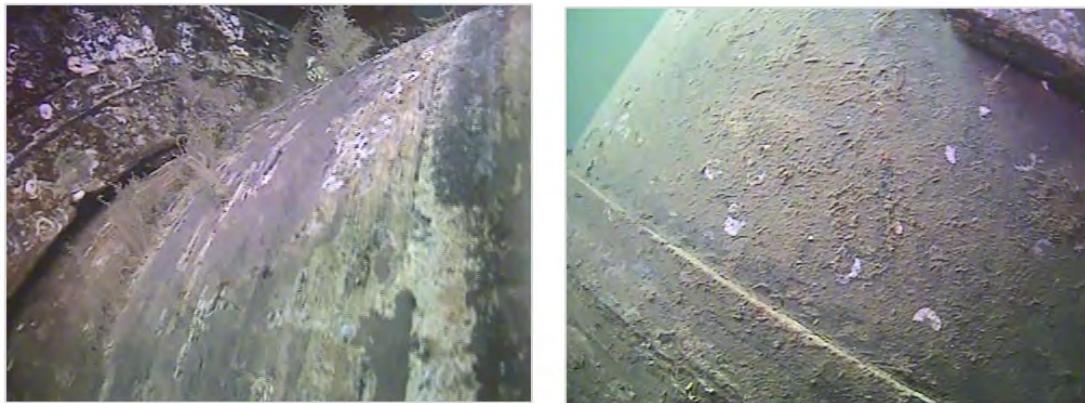
may have been established and missed during the cleaning (Figure 15). On this shaft, a layer of newly established biofilm and sedimentation had accumulated post hull cleaning (Figure 15). Lastly, an unidentified crab was observed inside the fairwater of the #1 port shaft, while an unidentified fish was present just outside of the #1 port stern tube (see Table 12).

Figure 15. Possible hydroids (left) and a biofilm-sediment layer (right) on the end of the #4 shaft.

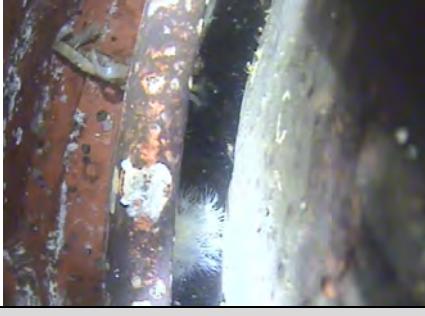
Stern Tube (Port #2)	Live tubeworm; live anemone (<i>Metridium sp.</i>); dead barnacle.

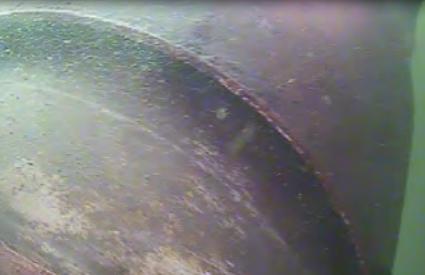
Stern Tube (Starboard #4)	No living fouling; paint and bare hull.	No photo available
Fairwater (Starboard Main Strut #4)	No living fouling; paint and bare hull.	No photo available
Shaft (#4)	No living fouling; tubeworm remnants.

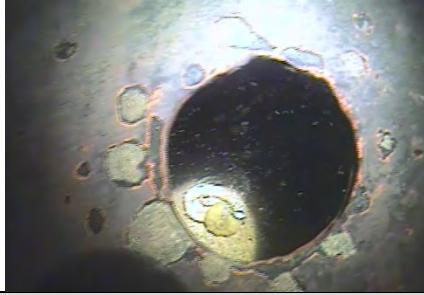
Vessel Feature	Description	Representative Image
Fairwater Hole (#1 Port Shaft)	Live tubeworm

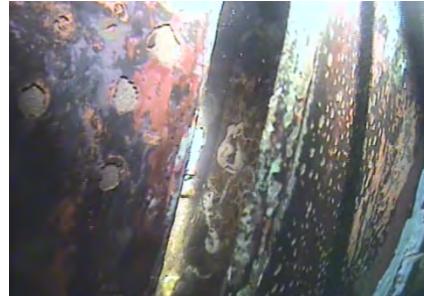
Fairwater (# Port Shaft)	No living fouling; tubeworm remnants; dead barnacle.	No photo available
Fairwater (#1 Port Shaft)	Live crab

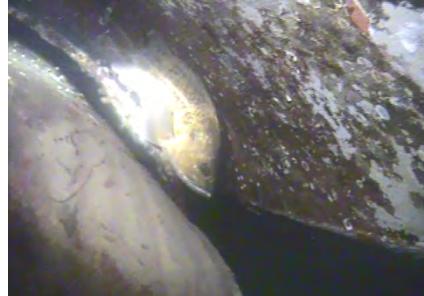
Stern Tube (Port #1)	Areas of no fouling, with a live tubeworm, mussel, and fish; dead tubeworm and barnacle.

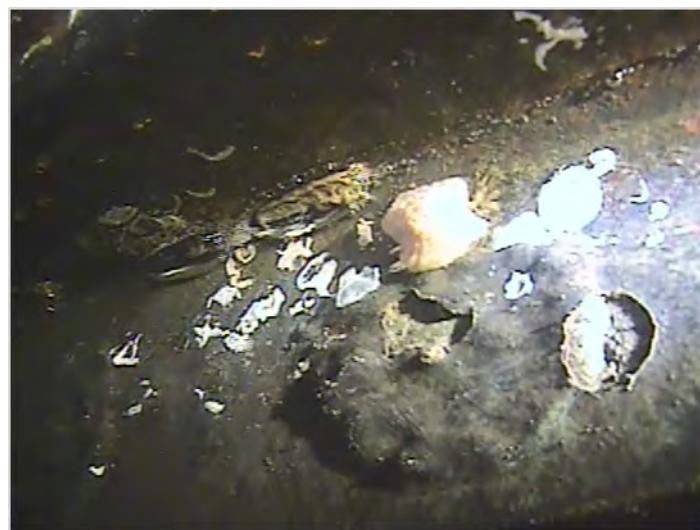
Figure 17. Retracted anemone (*Metridium* sp.) on the port bilge keel.

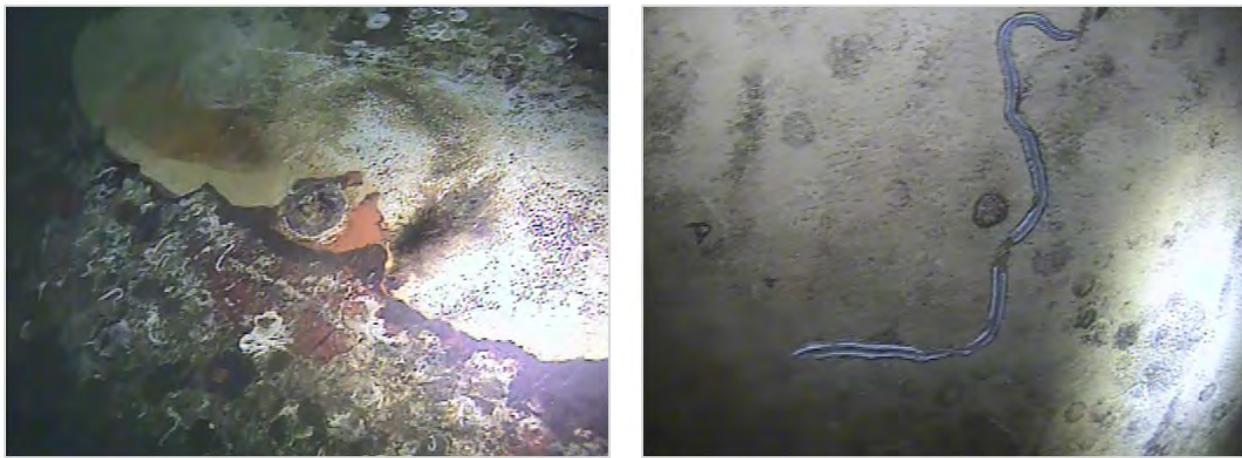
Figure 18. Patch of green algae on top of the port bilge keel (left) and a remnant of a calcareous tubeworm (right). Circular patches from removed barnacles or tubeworms are also visible (right).

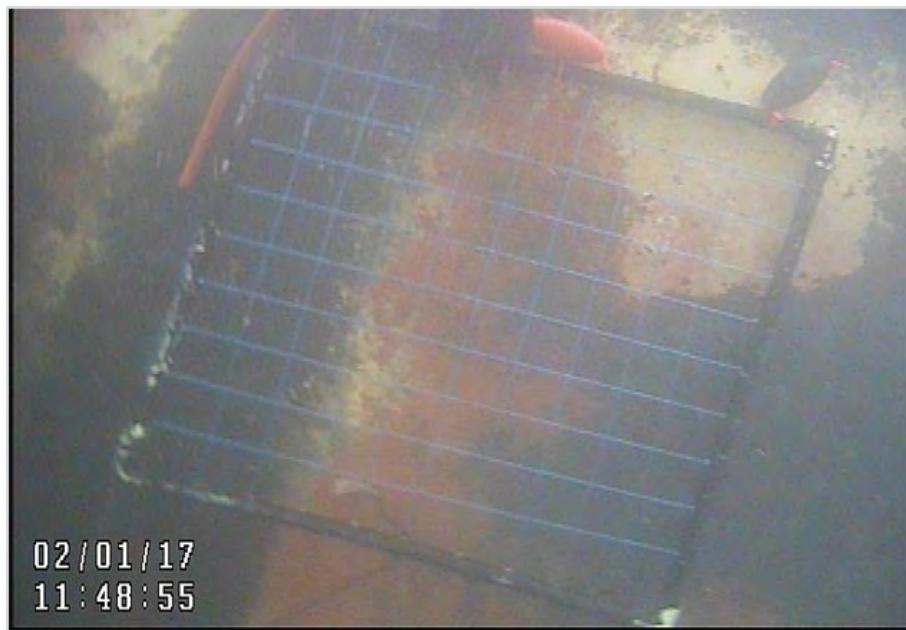
Little to no fouling was detected on any of the five belt transects. The only biofouling present consisted of a small patch of green algae on transect belt 1.5 which may have been new growth since the hull cleaning. Percent cover of paint ranged from 55 to 100%, with bare hull ranging from 0 to 45% (Figure 23 and Figure 24). Primer, the white coating observed in Figure 23, was also exposed at numerous stations. Remnants of barnacles (calcareous base plates), calcareous tubeworms, and unidentified mollusks were visible at a number of sample stations (Figure 25). Circular patches from the removal of barnacles and tubeworms could be seen at two sample stations (Figure 26).

Figure 23. Transect 1.5 Quadrat 1-P-S (frame 48) showing various antifouling (black and red) and primer (white) paint layers (99% paint/1% bare hull).

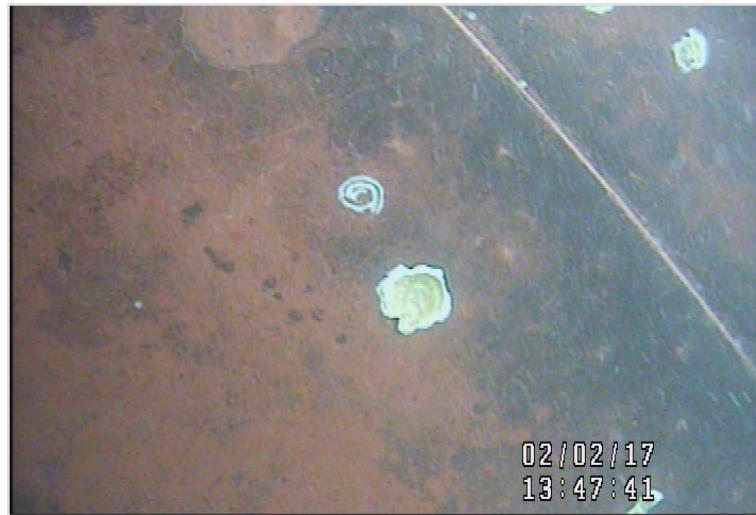
No living biofouling was present on the portions of the hull surveyed during this quantitative assessment. Remnants of calcareous tubeworms and mollusks were evident at one quadrat (Figure 29). Percent cover of antifouling paint ranged from 20 to 100%, with bare hull ranging from 0 to 80% (Figure 30). Representative areas where bare hull was exposed are shown in Figure 31.

Figure 29. Calcareous tubeworm and mollusk remnants from Quadrat 5 on the starboard hull.
