Monitoring to assess the effectiveness of an activated carbon sediment amendment to remediate contamination at a site located at the Puget Sound Naval Shipyard & Intermediate Maintenance Facility, Bremerton, WA

D.B. Chadwick,¹ V. Kirtay,¹ G.H. Rosen,¹ R.K. Johnston,¹ J. Guerrero,¹ J. Germano,² J. Conder,³ and C. Stransky⁴

1. Space and Naval Warfare Systems Center Pacific, San Diego CA

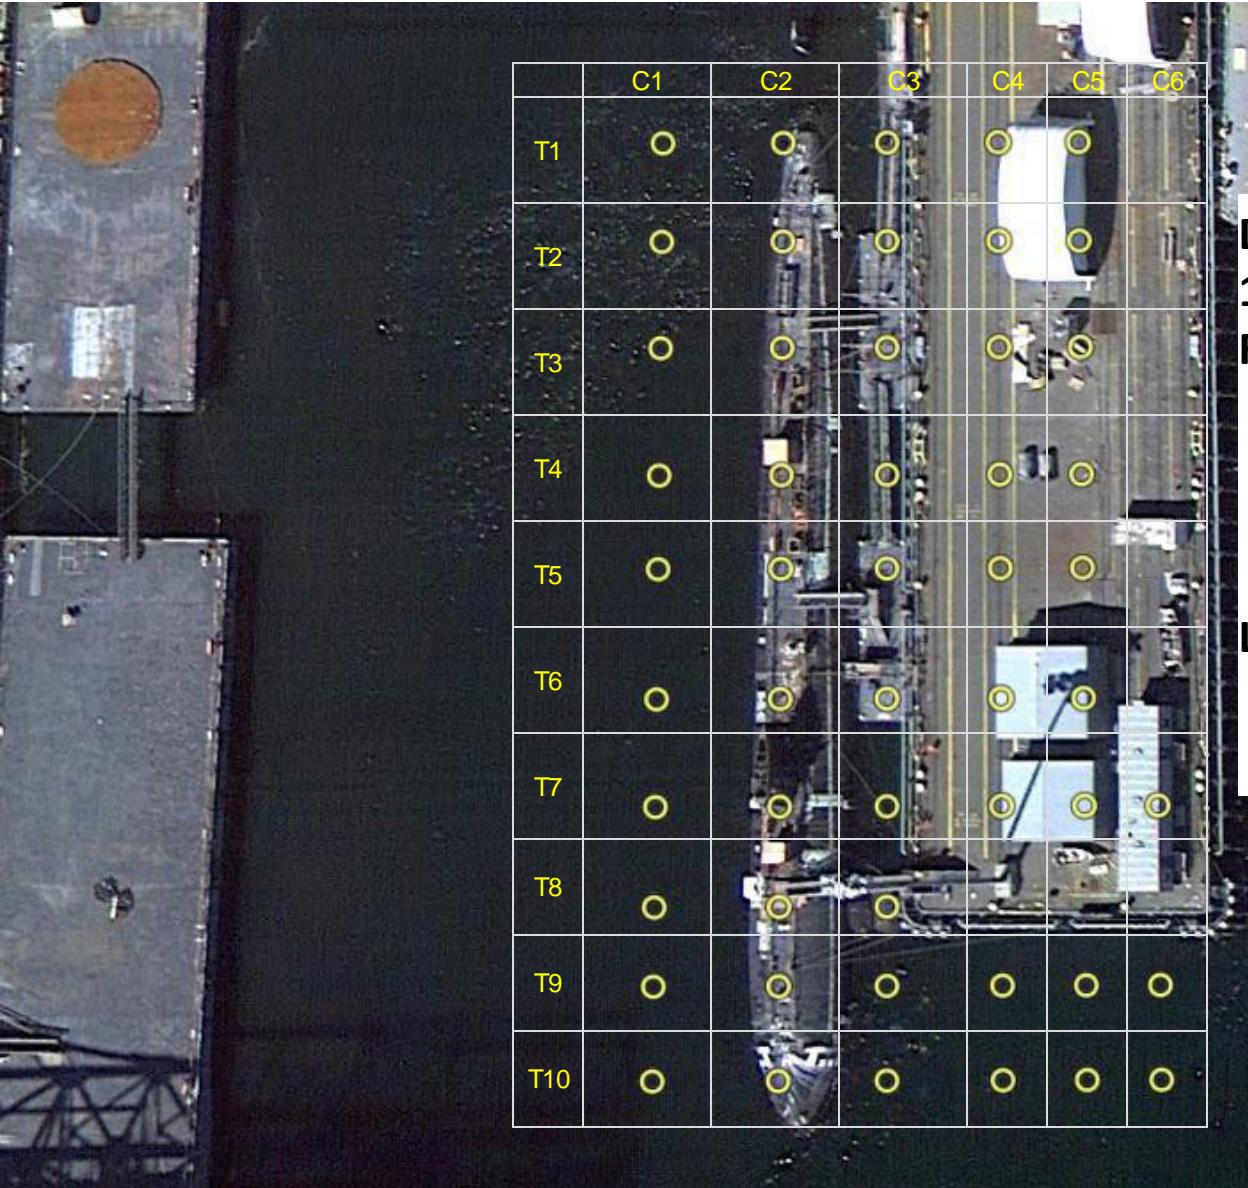
Pier 7 Screening Analysis - Methods

Diver Collected Samples

10 cm surface cores

Rapid Screening

PCBs, PAHs

- ImmunoAssay

Cu, Pb, Zn

- XRF

Lab Analysis

Hg – CVAA

Grain Size Distribution

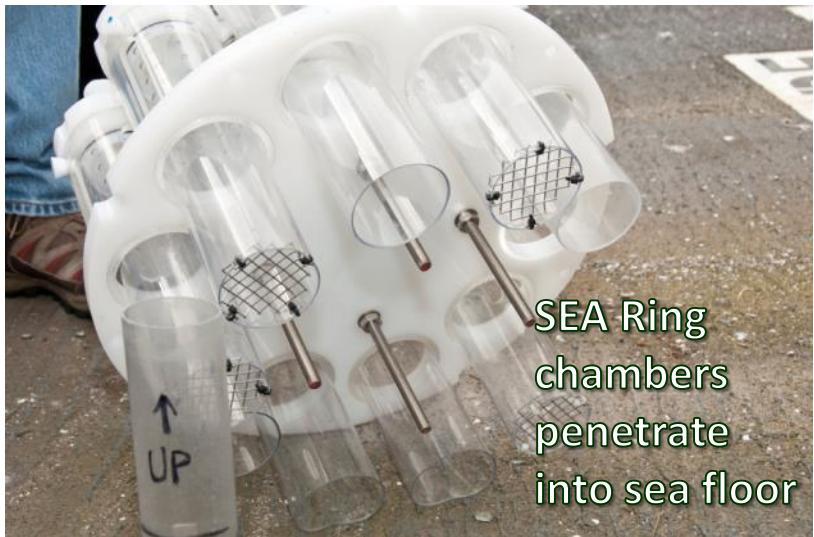
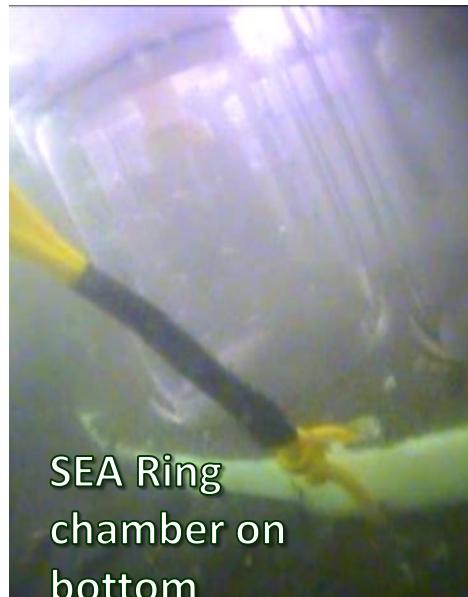
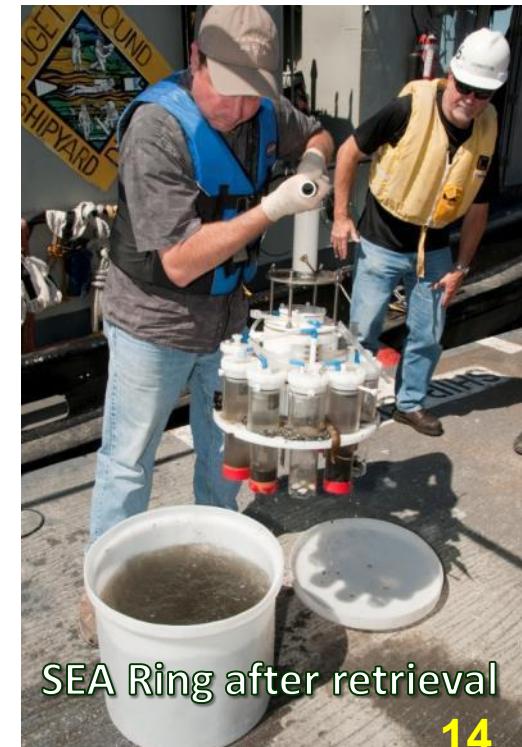
Sediment Ecotoxicity Assessment

SEA Ring

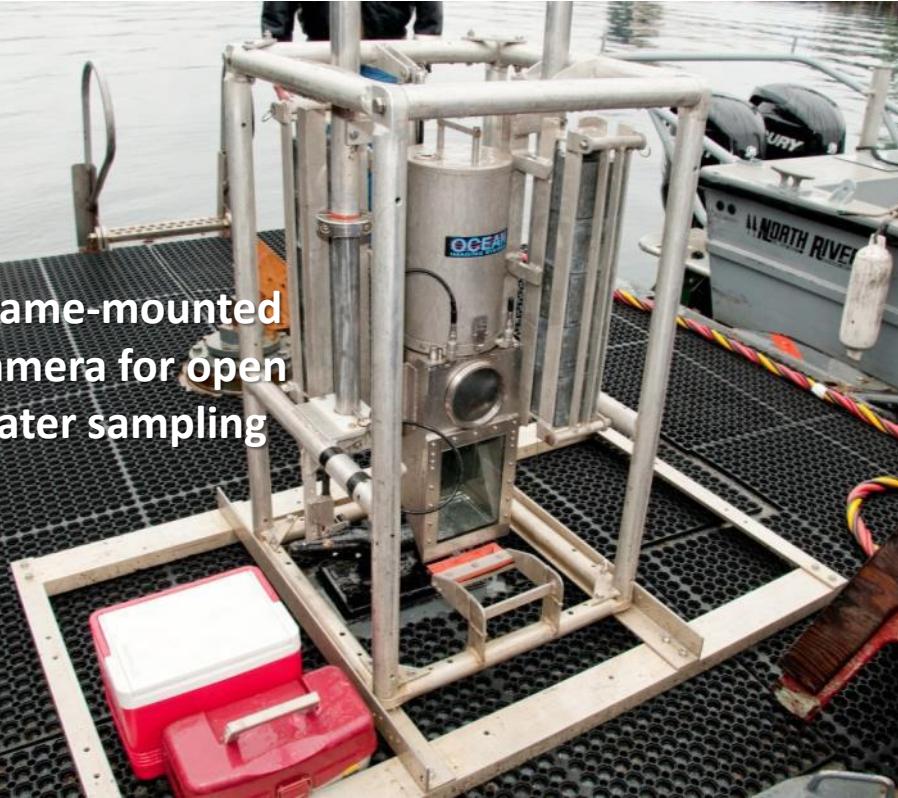
Frame-mounted
camera for open
water sampling

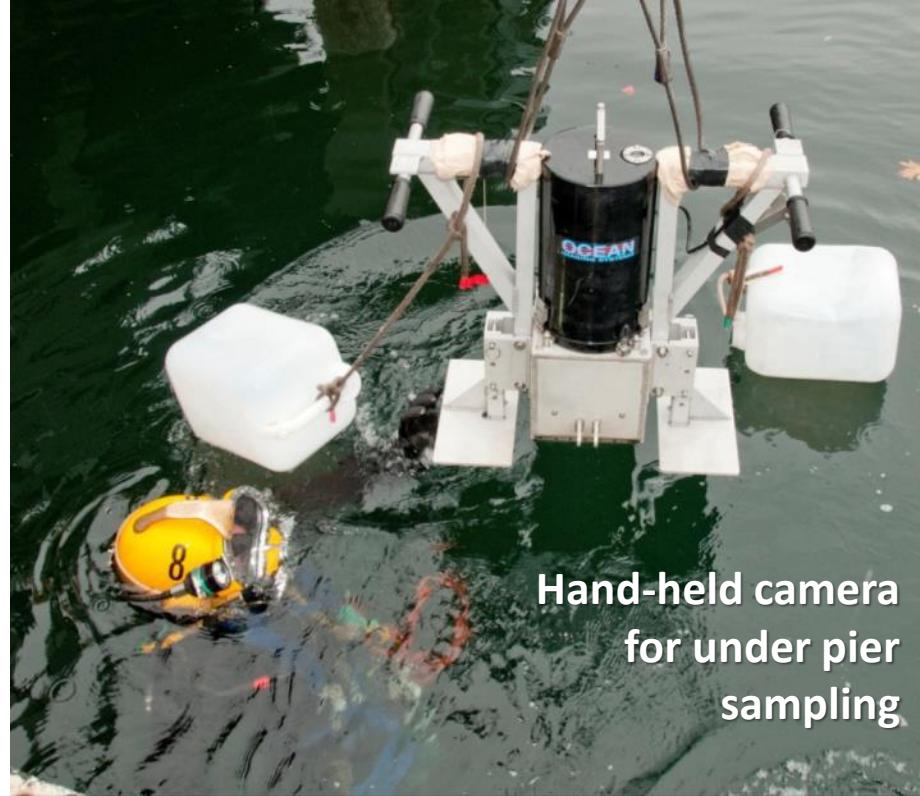
Hand-held camera
for under pier
sampling

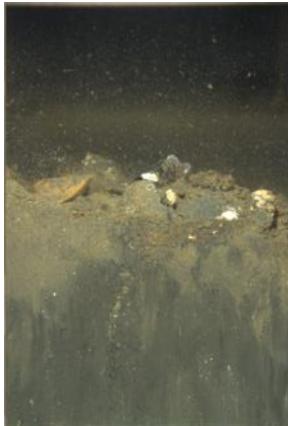
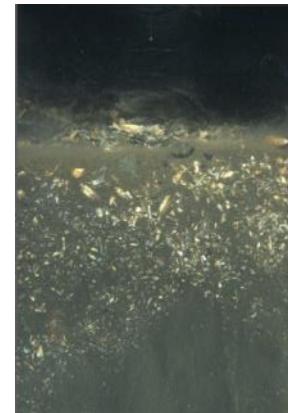
Sediment Profile Images

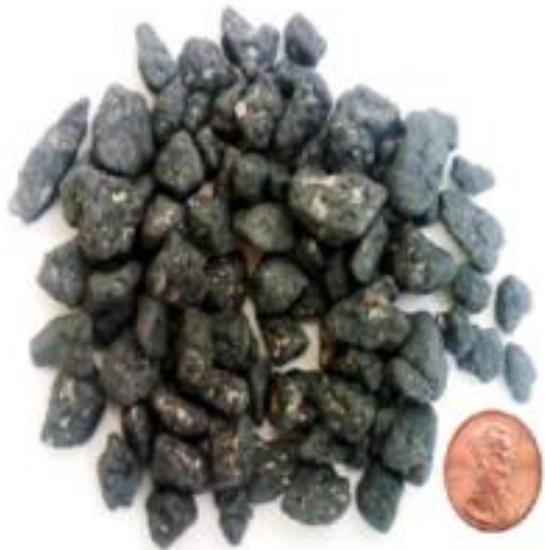
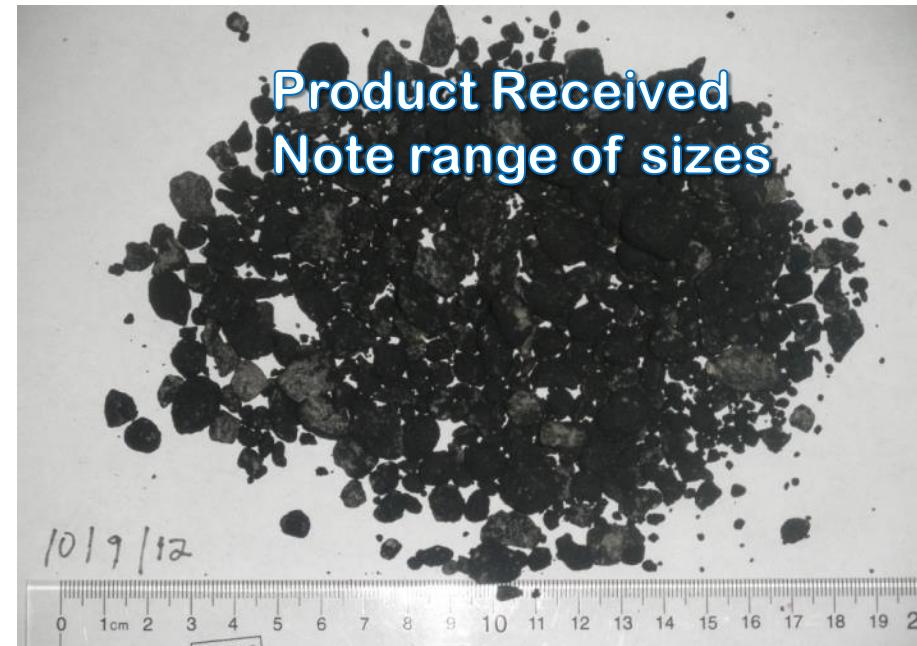
AquaGate+PAC™ Composite Aggregate

Dry State – Pre-Placement

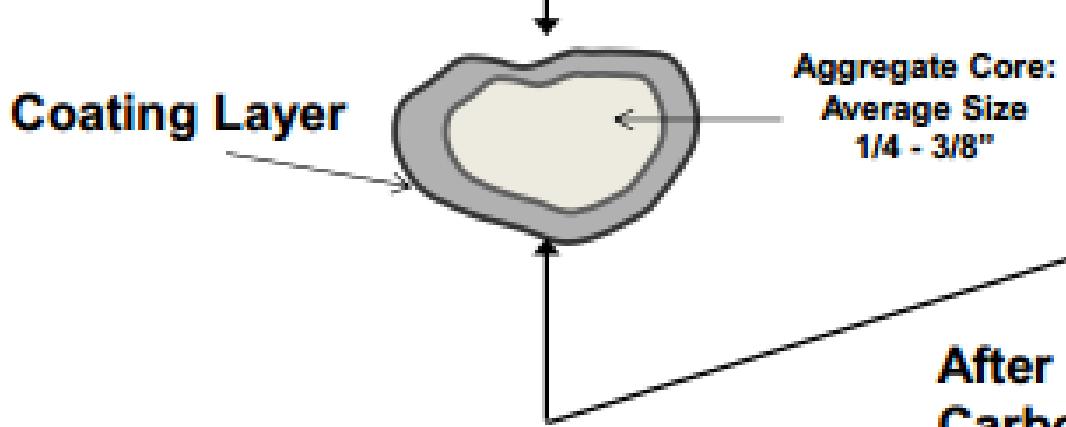
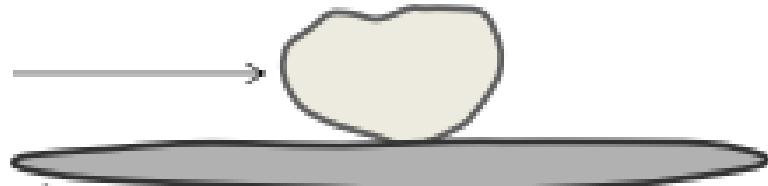
Post-Placement

After Placement – Powder Activated Carbon Falls off Core and Mixes Naturally with Sediment

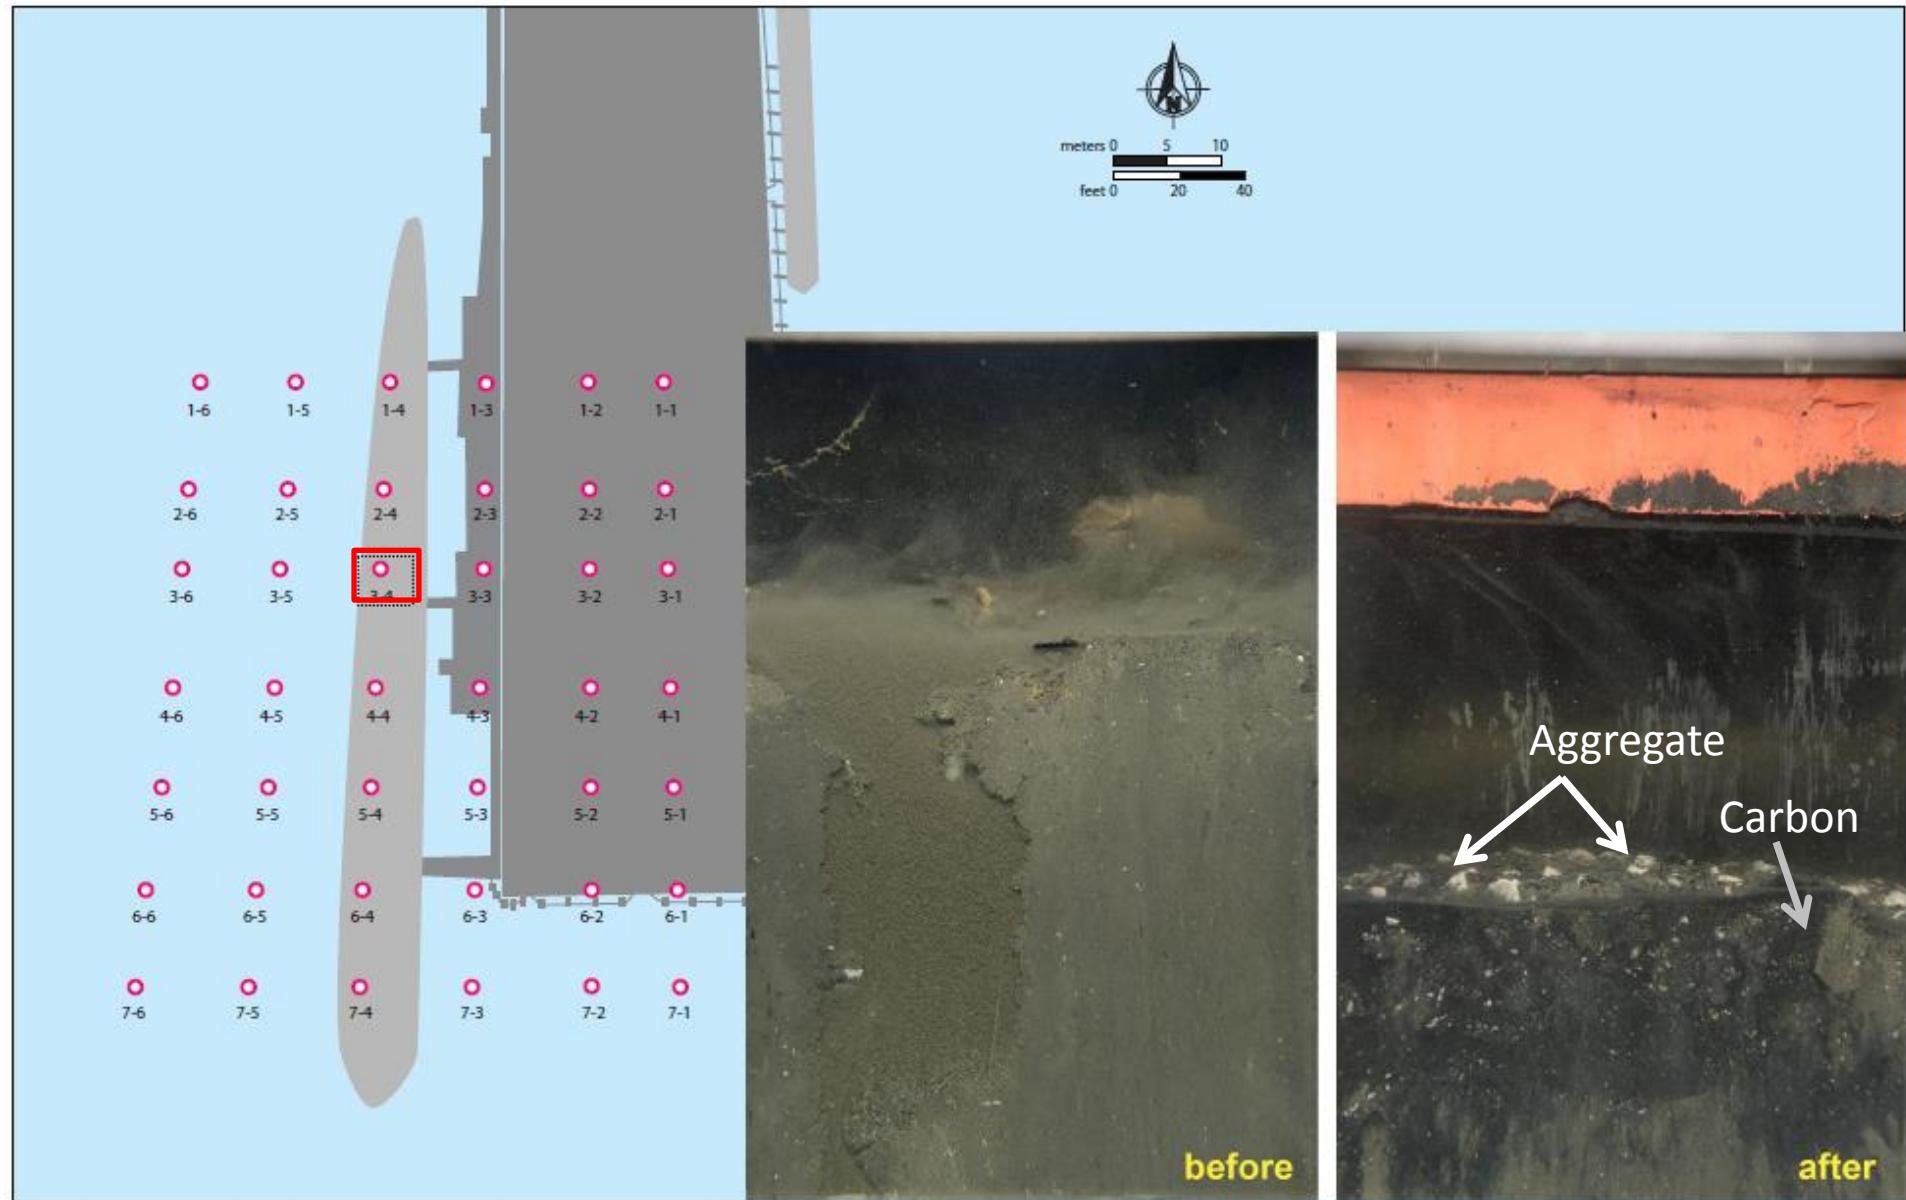
Sediment Profile from SPI camera

Average Activated Amendment Cap Layer Thickness (cm)

- area with detectable thickness
- area with a trace

Thickness of Amendment Cap Following Placement Oct 2013 (T=0.5 month)

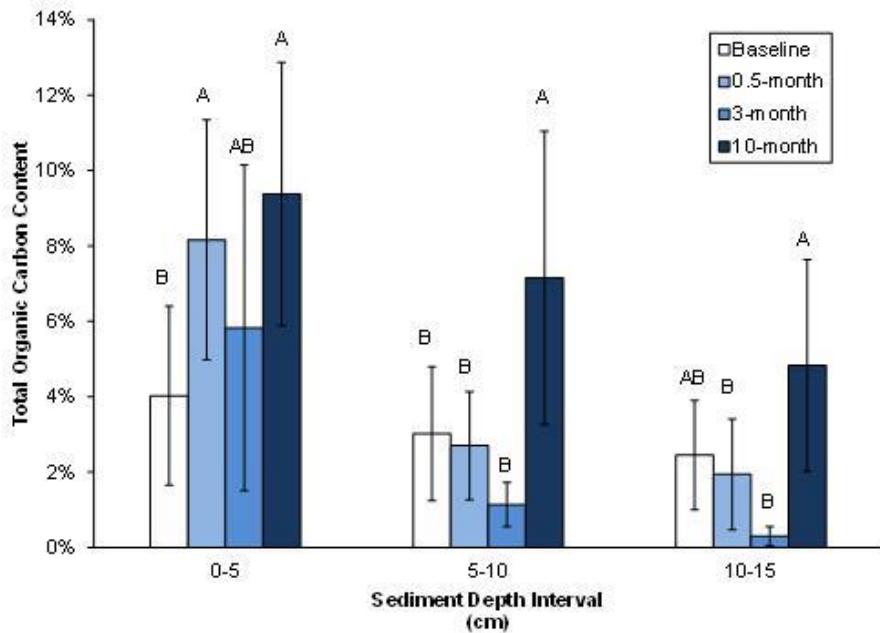
TOC

- Measurements confirm increase in carbon content in sediment
 - Expected increase in carbon following installation; ~2x increase in surficial (0-5 cm) layers from 4% to 8% TOC.
 - At 10-mo there appears to be an increase in carbon at deeper levels.
 - Variability across site; look at trends not mass balance.
 - Further investigation into sample processing and analysis methods to address bias.

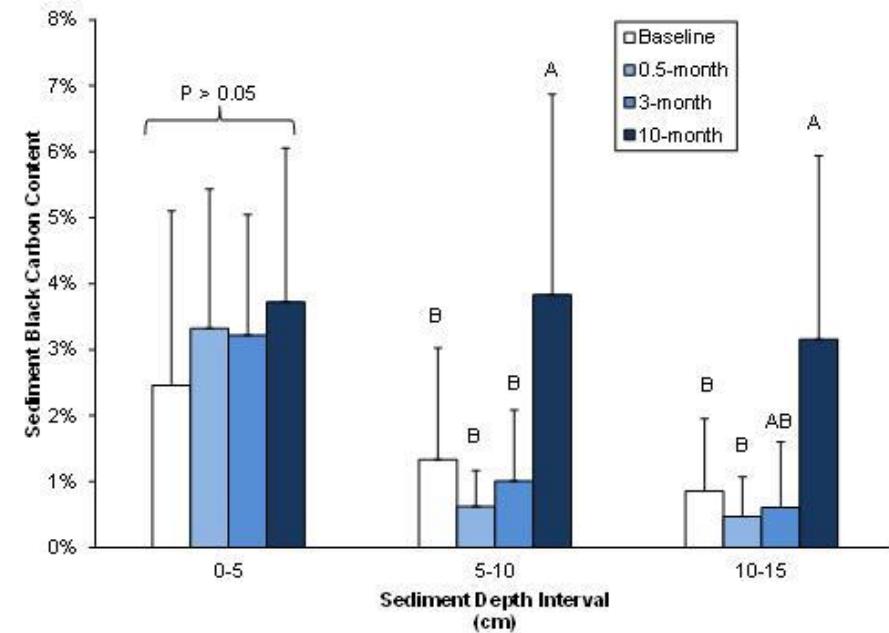
Black Carbon

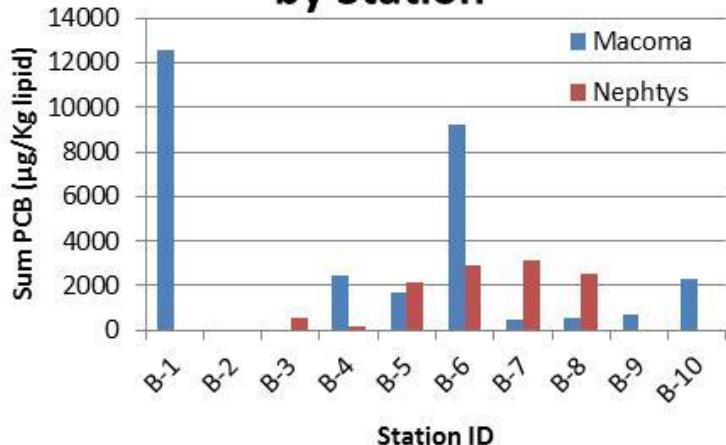
Baseline Bioaccumulation by Station

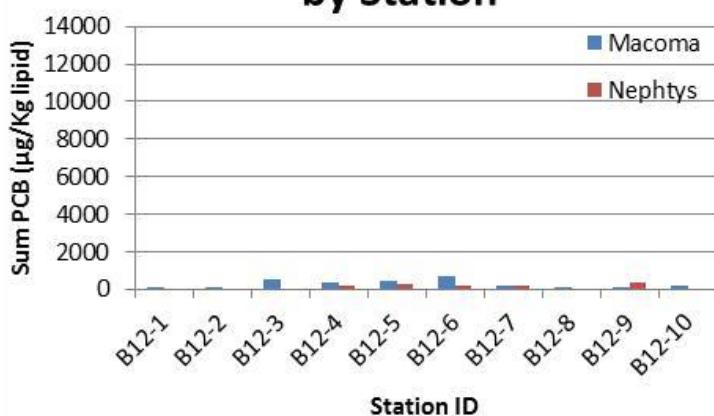
T=10 mo Bioaccumulation by Station

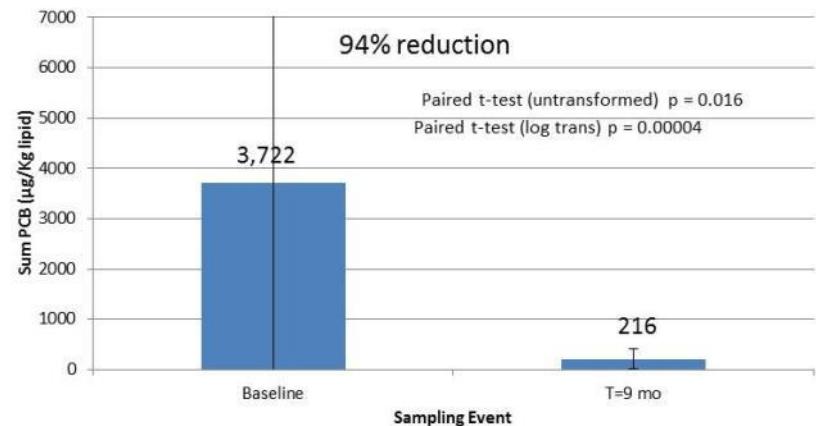
Sum PCB Bioaccumulation (all data, lipid norm)

Baseline and T=10 months (n=24)

Significant reduction (~90%) in PCB bioavailability to sediment invertebrates

- Concurrence with 90% reduction observed in the initial lab study.
- Sum of detected PCB congeners for all organisms used in bioaccumulation exposures during Baseline and T=10-mo post-remedy.
- Paired t-tests showed highly significant differences between baseline and post-remedy.
- Reduction in PCB bioaccumulation was apparent in both species: *Macoma nasuta* and *Nephtys caecoides*.
- Reduction in PCB bioaccumulation consistent across stations.

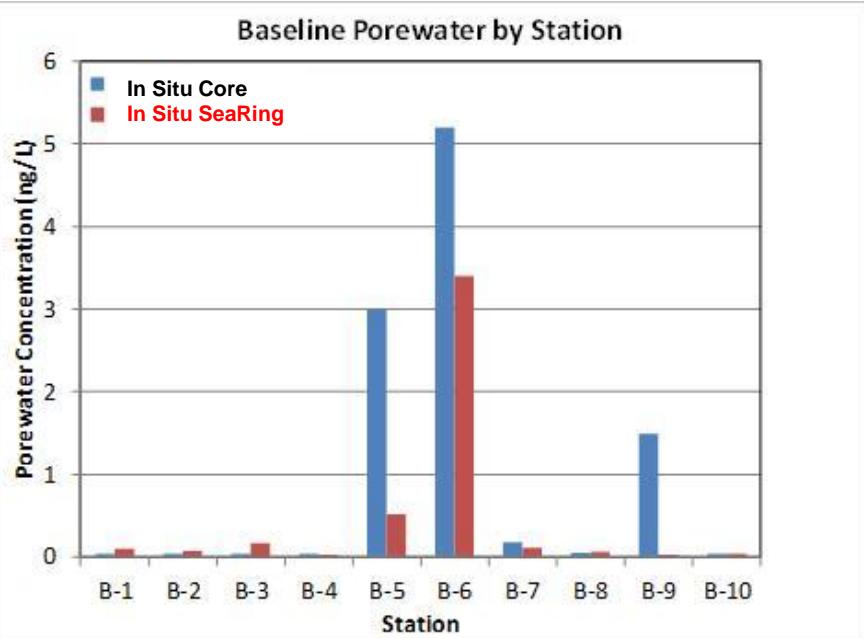
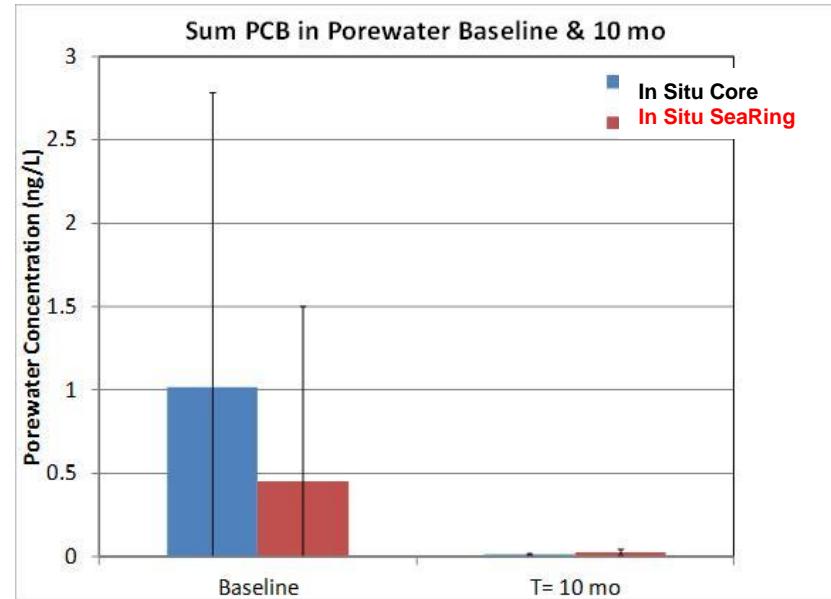
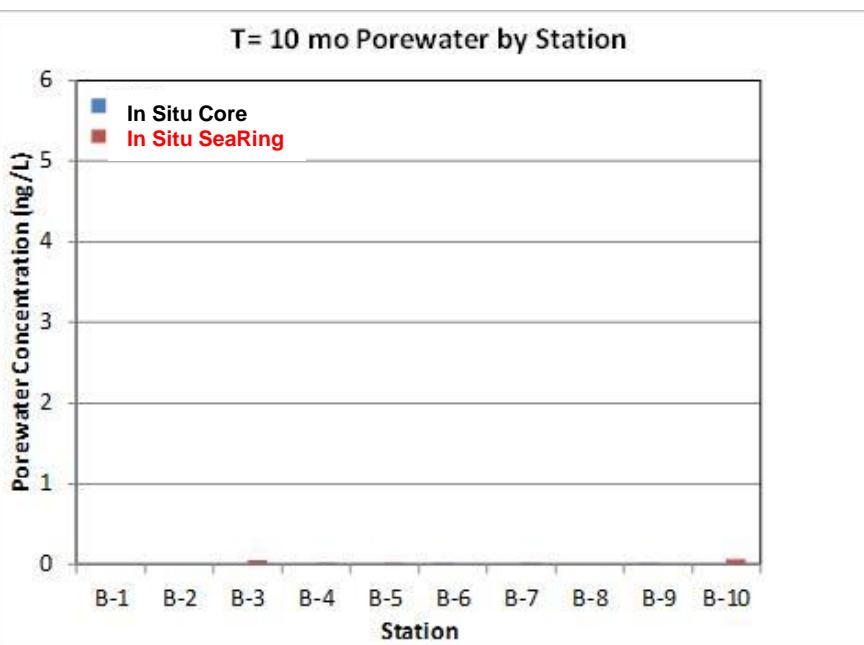
PCBs in Porewater Measured by Passive Samplers

- **Similar reduction (~95-99%) in PCBs in porewater as observed in invertebrate tissues**
 - Concurrence with reduction observed in the initial lab study.
 - Sum of detected PCB congeners for both SPME exposures (in situ SeaRing and in situ cores) used during Baseline and T=10-mo post-remedy.
 - 99% and 95% reduction in mean based on SeaRing and Cores, respectively.
 - Reduction in PCB levels in porewater was apparent in both in-situ (SEA Ring) exposures and lab core exposures.
 - Reduction in PCBs in porewater was consistent across stations.

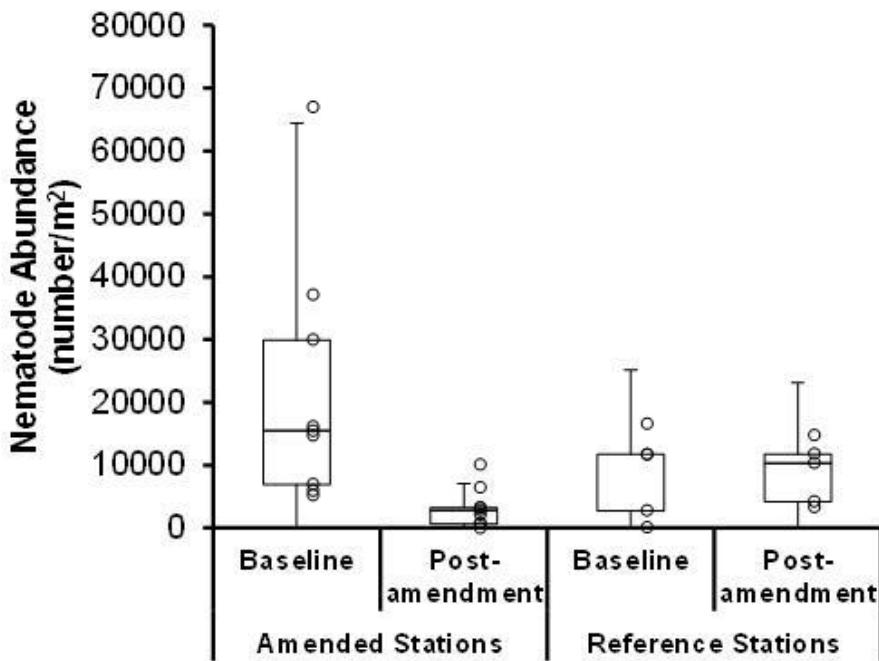
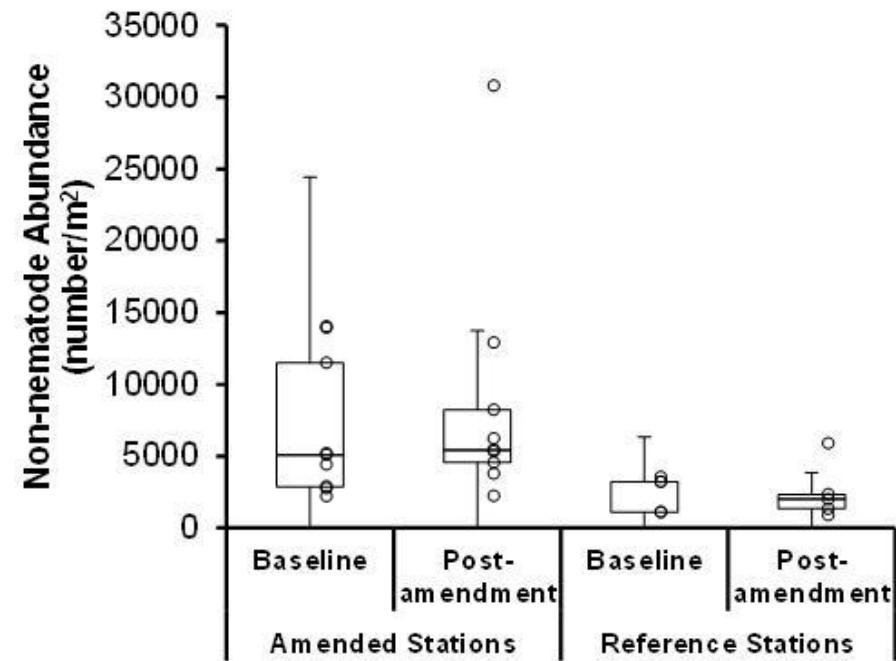
Benthic Census Evaluation (Tracking Purposes Only)

Slight shifts in community structure observed

- Abundance at the amended stations decreased between baseline and 10-month (post-amendment) surveys, but was driven by nematode abundance decreases.
- Abundance of non-nematode invertebrates at the amended stations was comparable to that of the reference stations.
