Results from the West Sound Mussel Watch Monitoring and Effectiveness Monitoring of an Activated Carbon Sediment Amendment at a Contaminated Site

Presentation for West Sound Science Seminar
Poulsbo, WA, March 5, 2015

Monitoring the effectiveness of an activated carbon sediment amendment at a contaminated site located at the Puget Sound Naval Shipyard & Intermediate Maintenance Facility (PSNS&IMF), Bremerton, WA

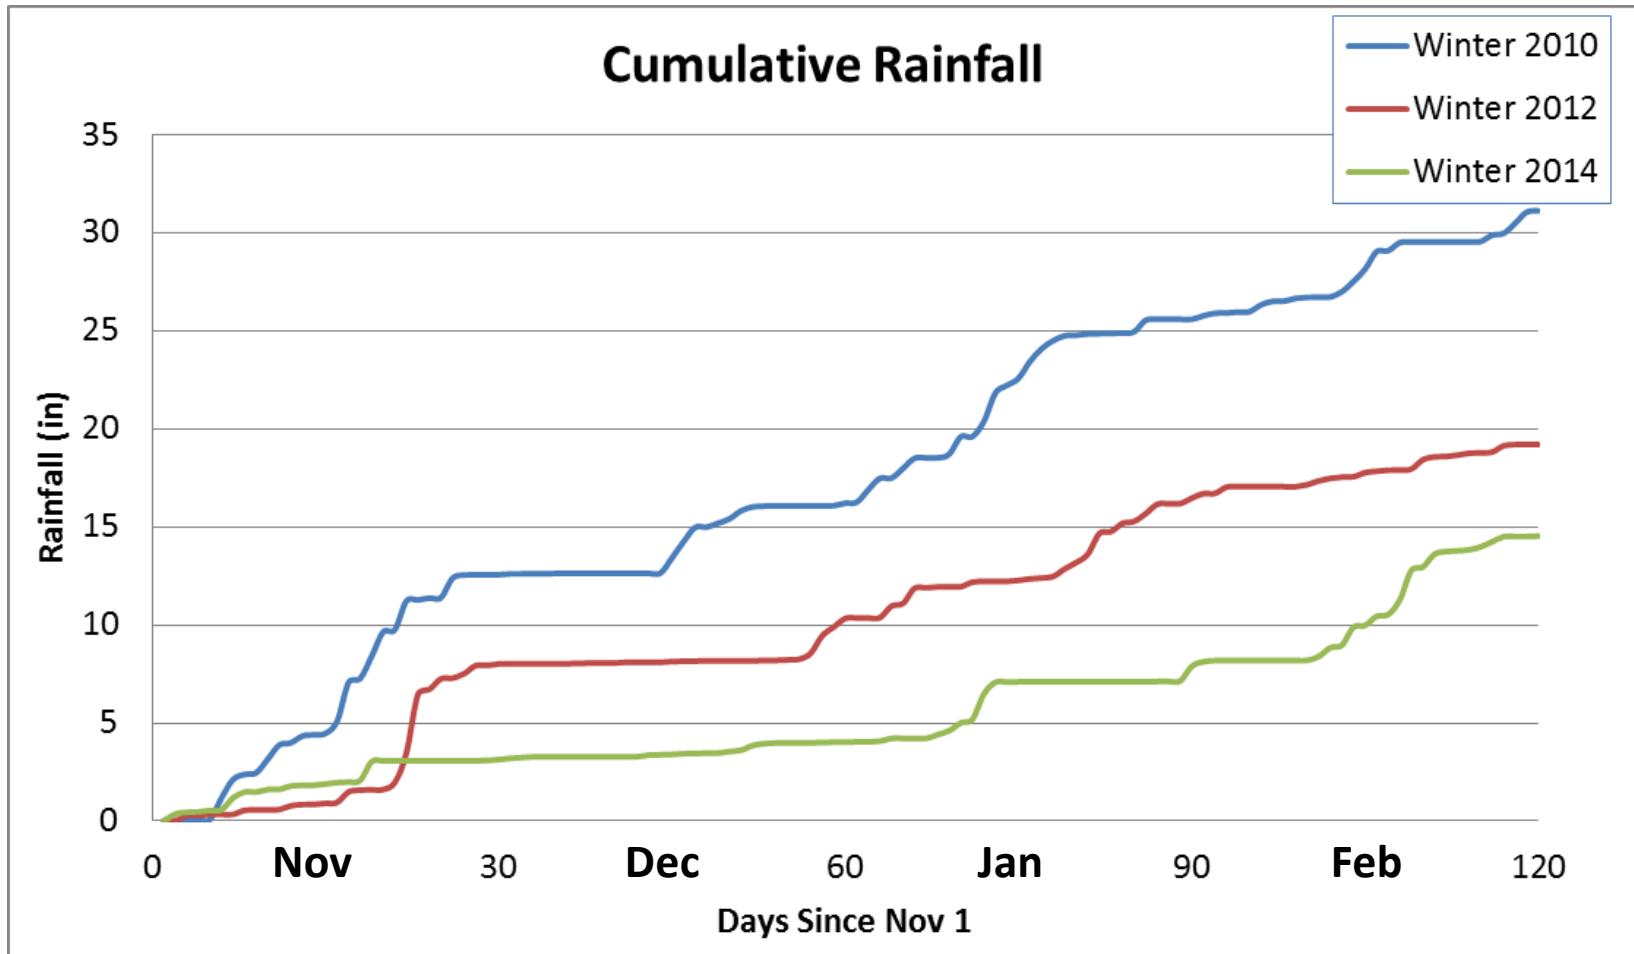
Winter Sampling Nov - Feb

Sum of average daily rainfall reported from Kitsap County rain gauges (CoCoRaHS 2014)

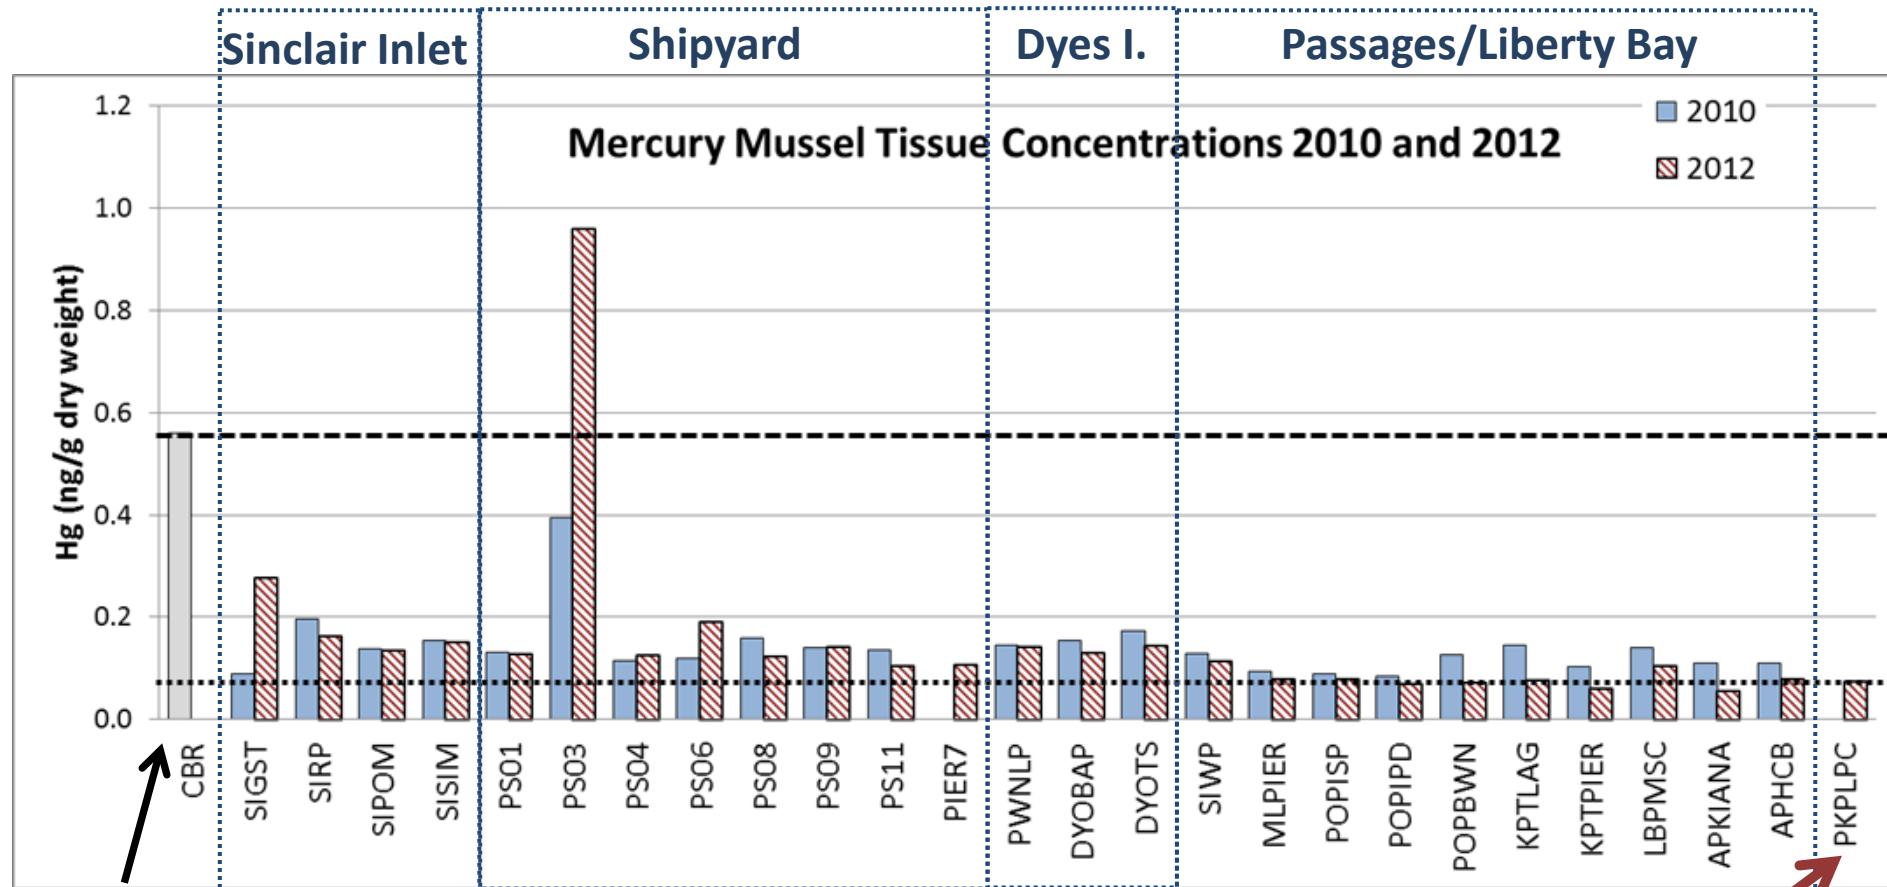
Mercury (Hg)

Critical
Body
Residue

National MW Range
ppm dry weight

Hg
Low	0.00 - 0.17
Medium	0.18 - 0.35
High	0.36 - 1.28

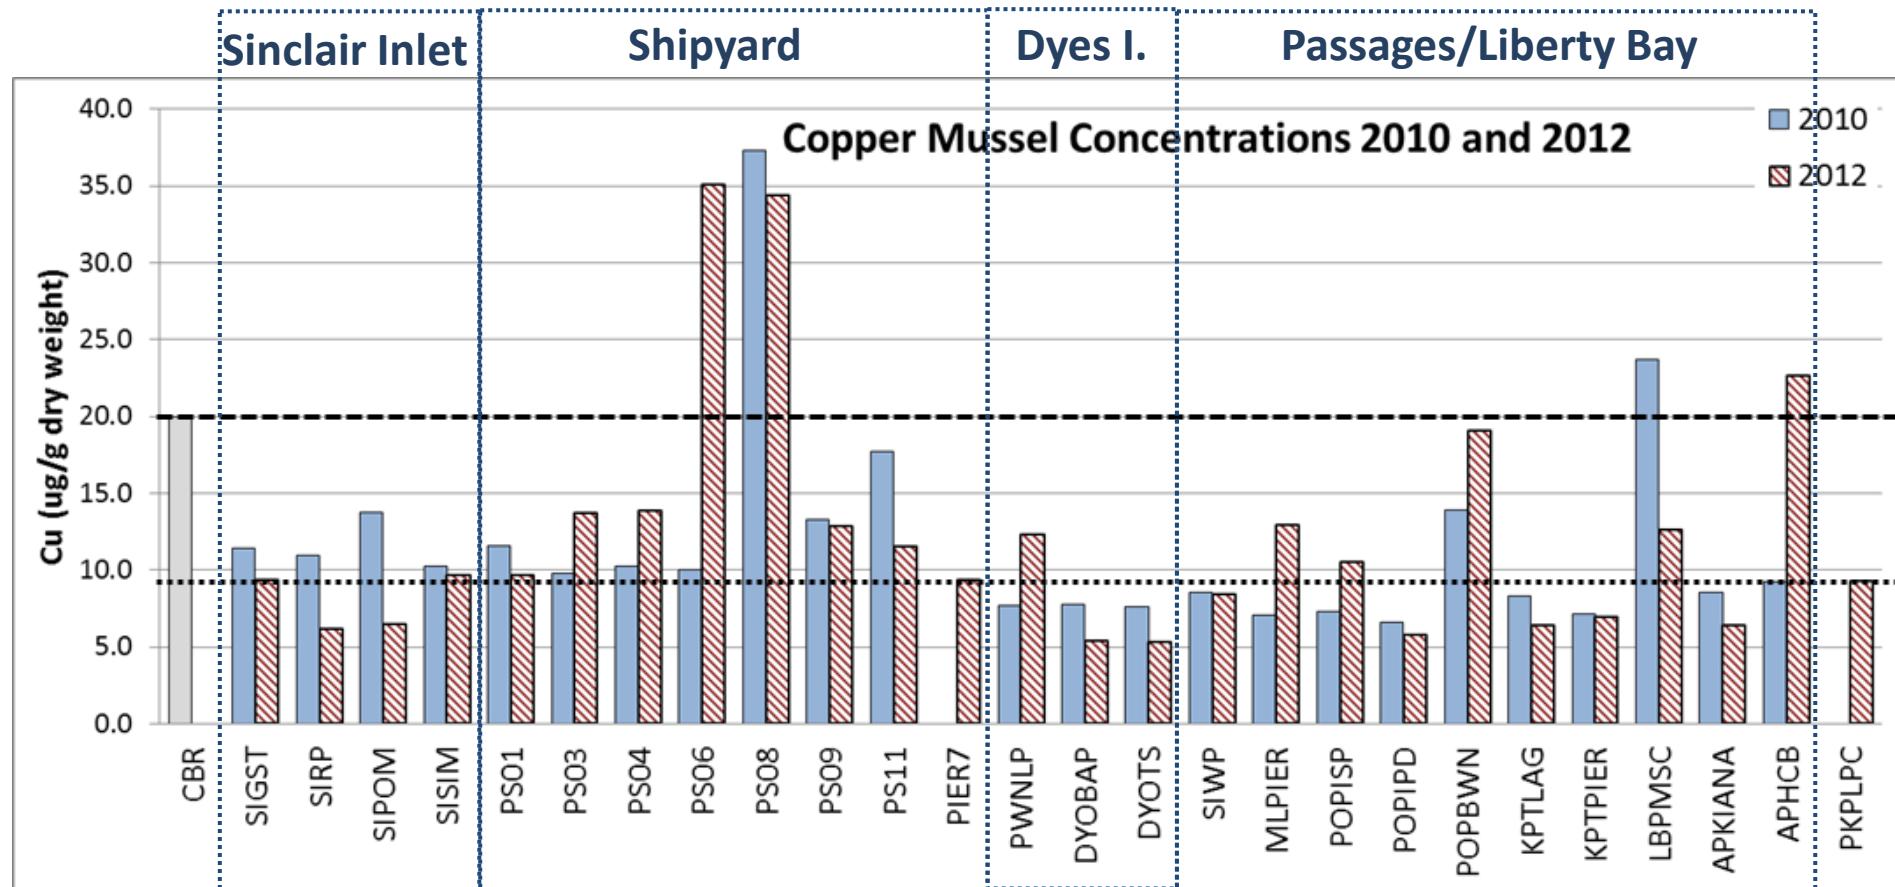
Copper (Cu)

National MW Range
ppm dry weight

Cu
Low	5 - 16
Medium	17 - 39
High	40 - 857

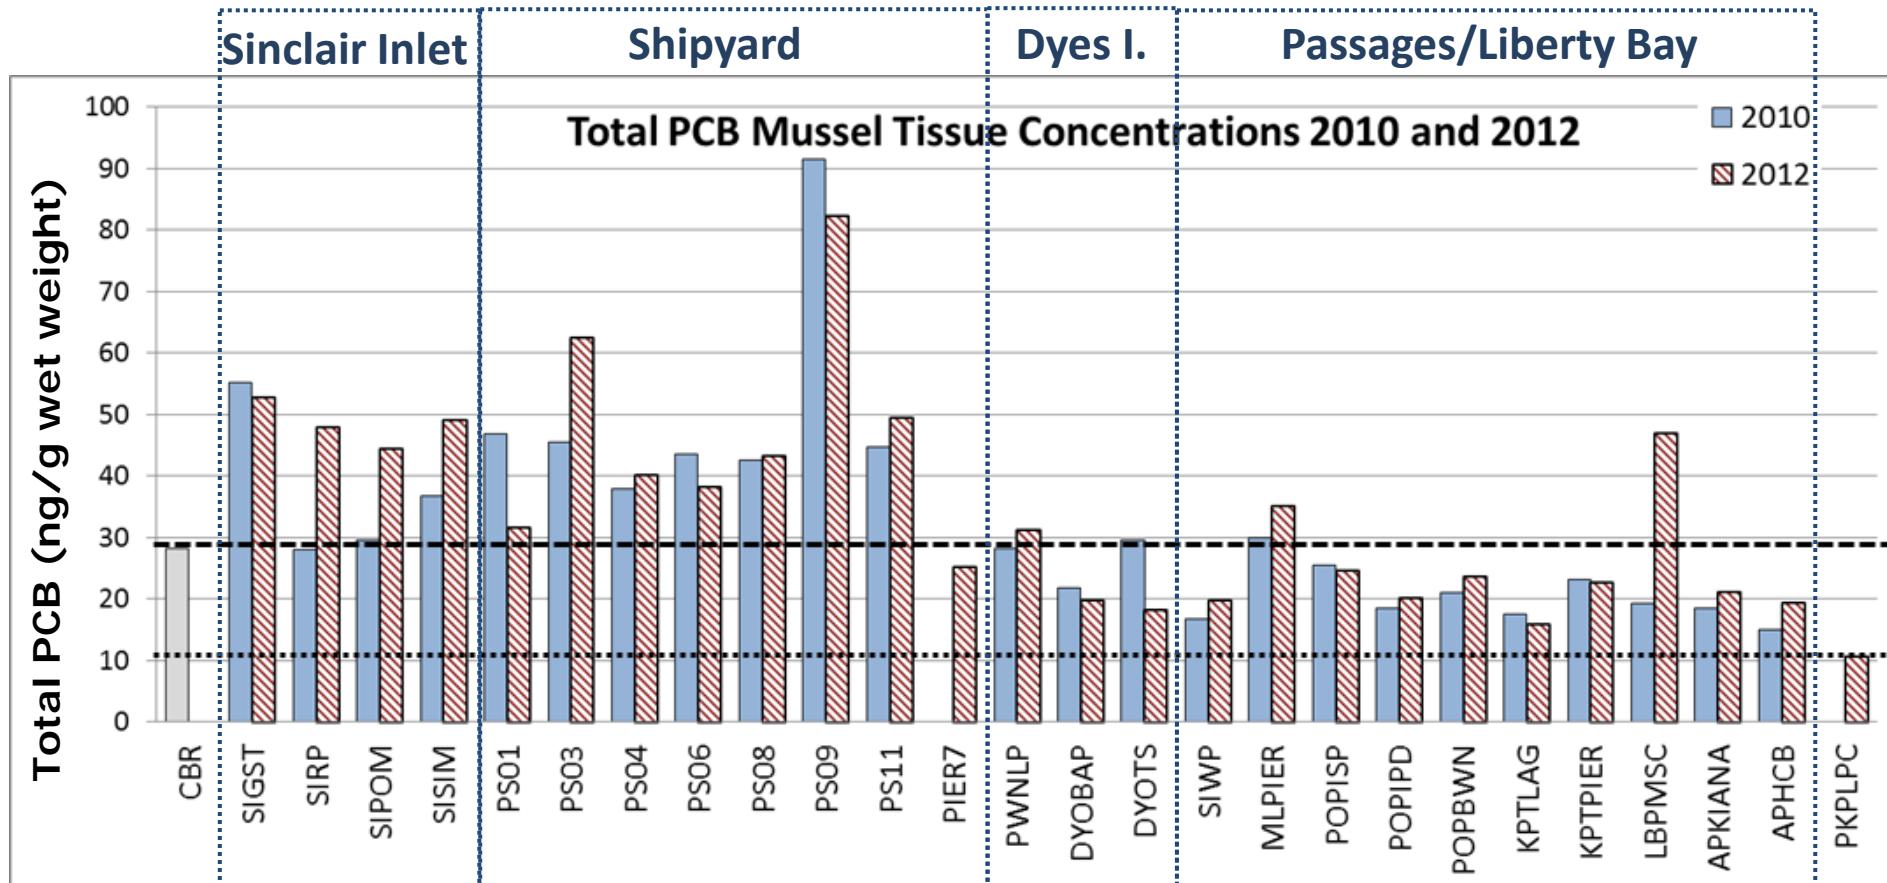
Total Polychlorinated Biphenyl (PCB)

National MW Range
ppb wet weight

PCBs
Low	0.4 - 21.3
Medium	21.5 - 66.6
High	66.8 - 197

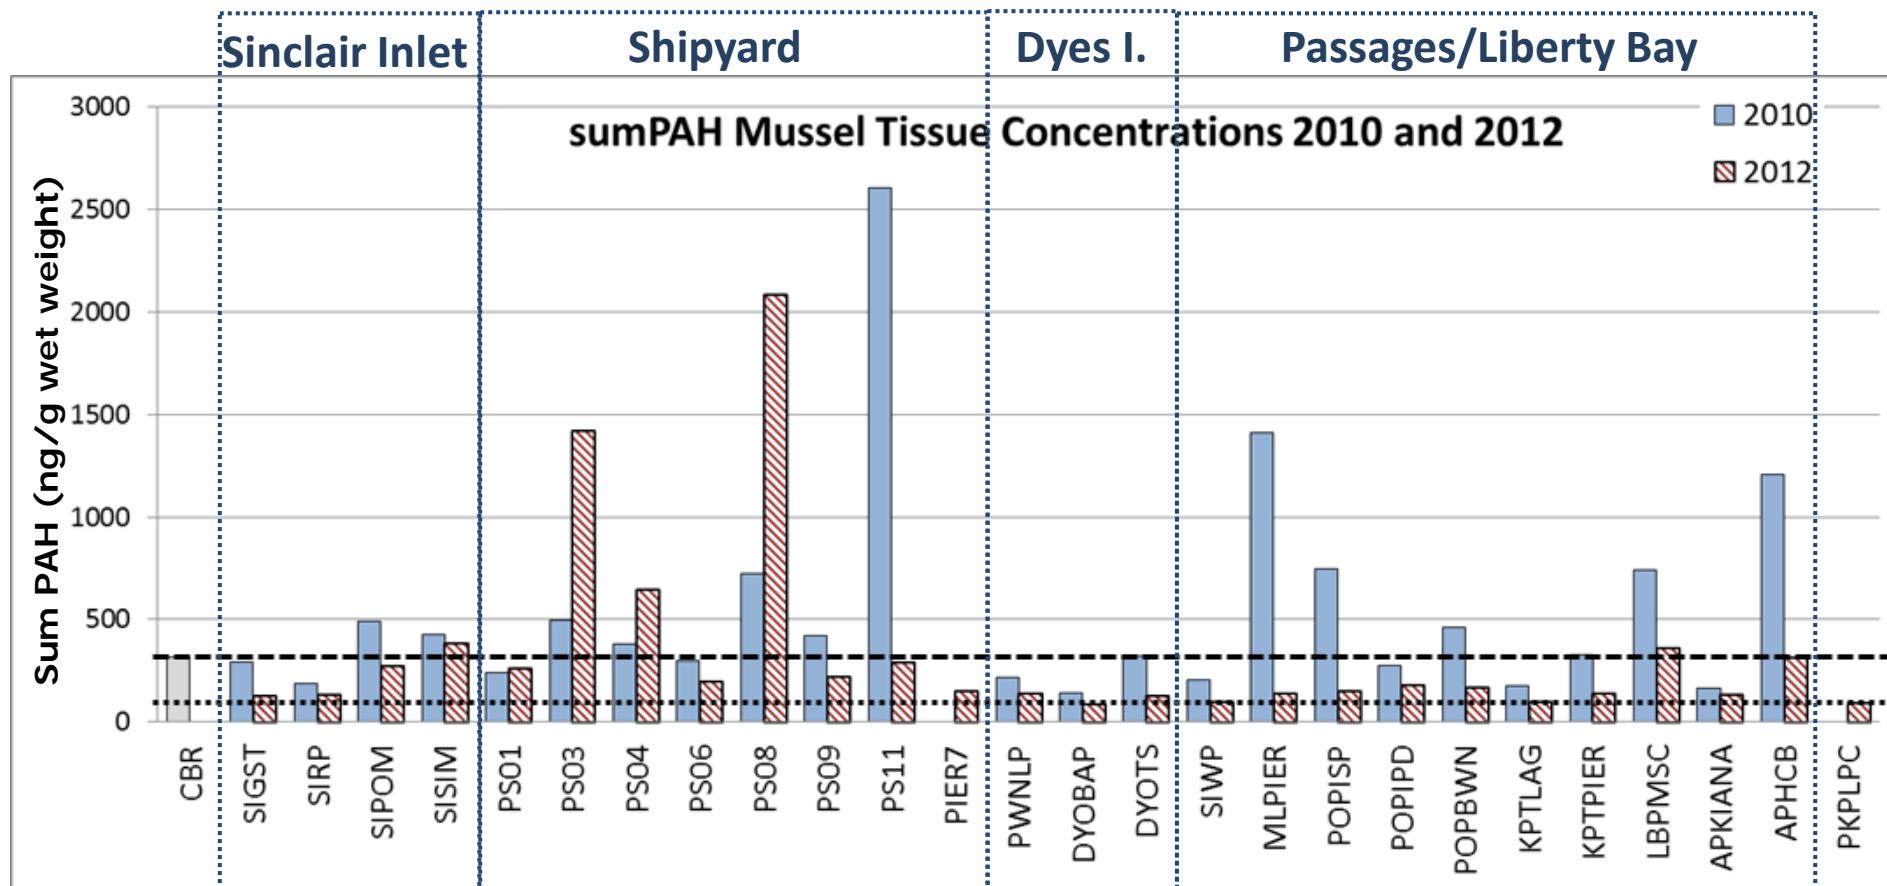
Sum of Polycyclic Aromatic Hydrocarbon (PAH) Compounds

National MW Range
ppb wet weight

PAHs
Low	9 - 165
Medium	166 - 618
High	618 - 1054

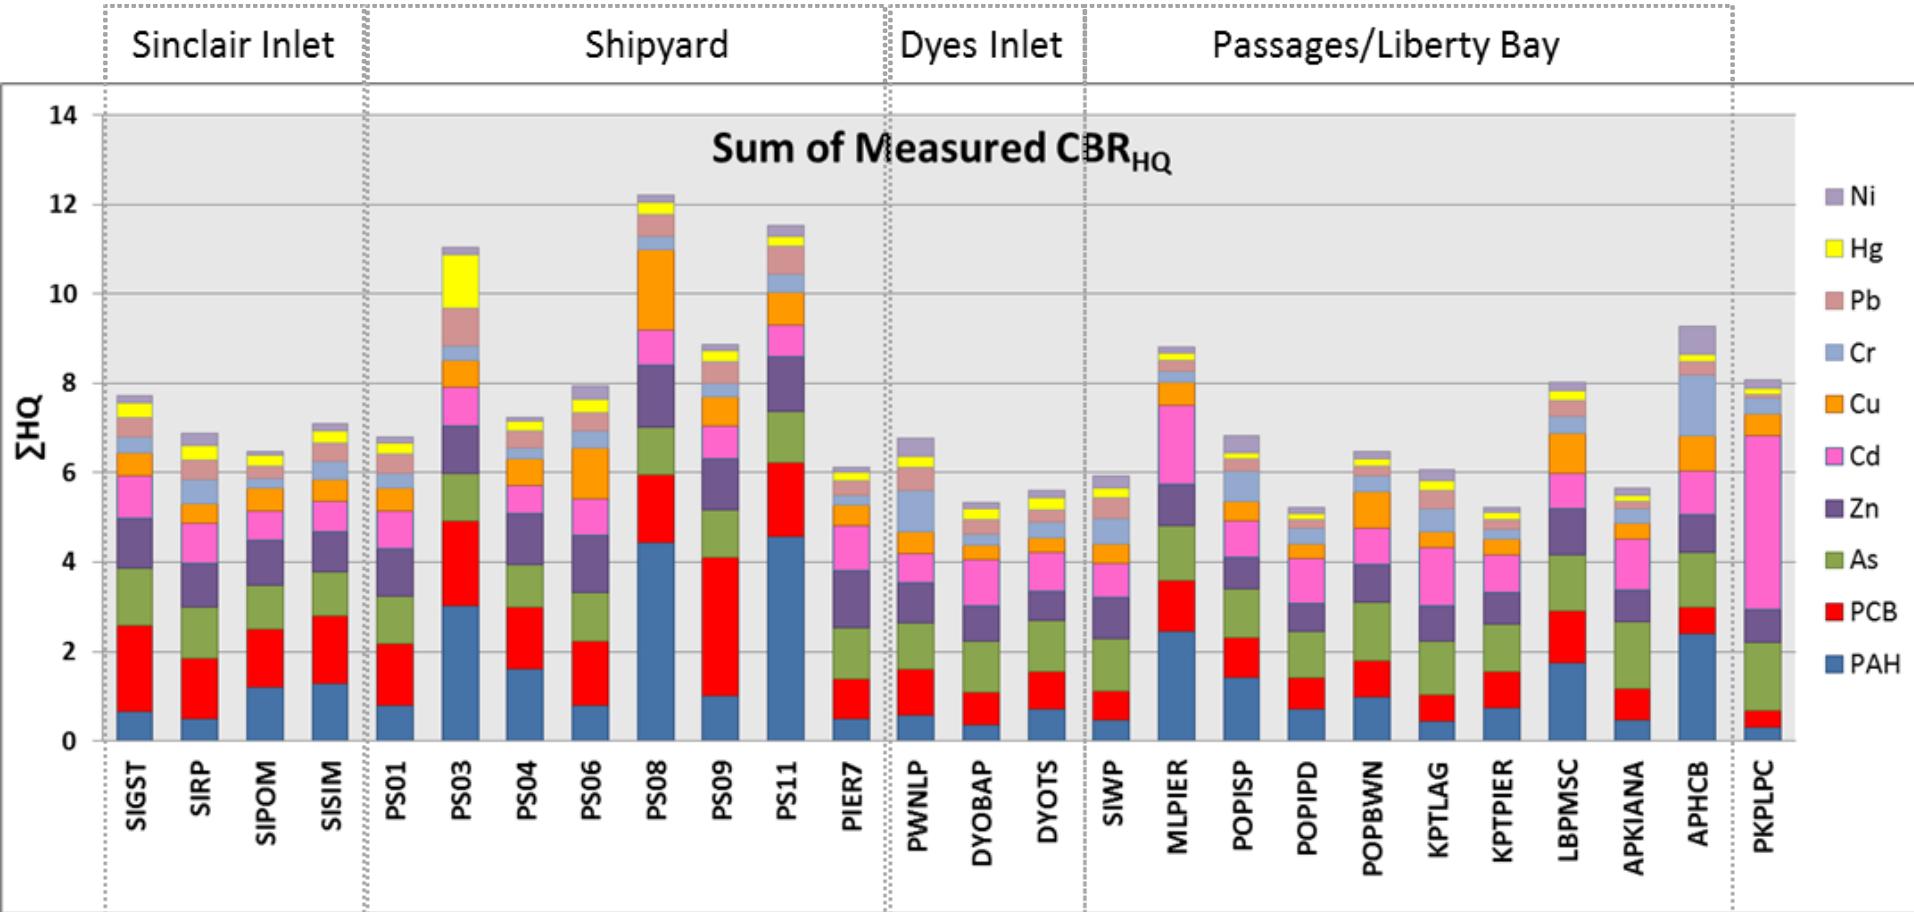
Hazard Index for Critical Body Residues

Possible Ecological Effect – Critical Body Residue

$CBR_{HQ} > 2$; $CBR_{HQ} = \text{Concentration}/CBR_i$

$CBR_{HI} > 10$; $CBR_{HI} = \sum CBR_{HQi}$ where $i = 10$

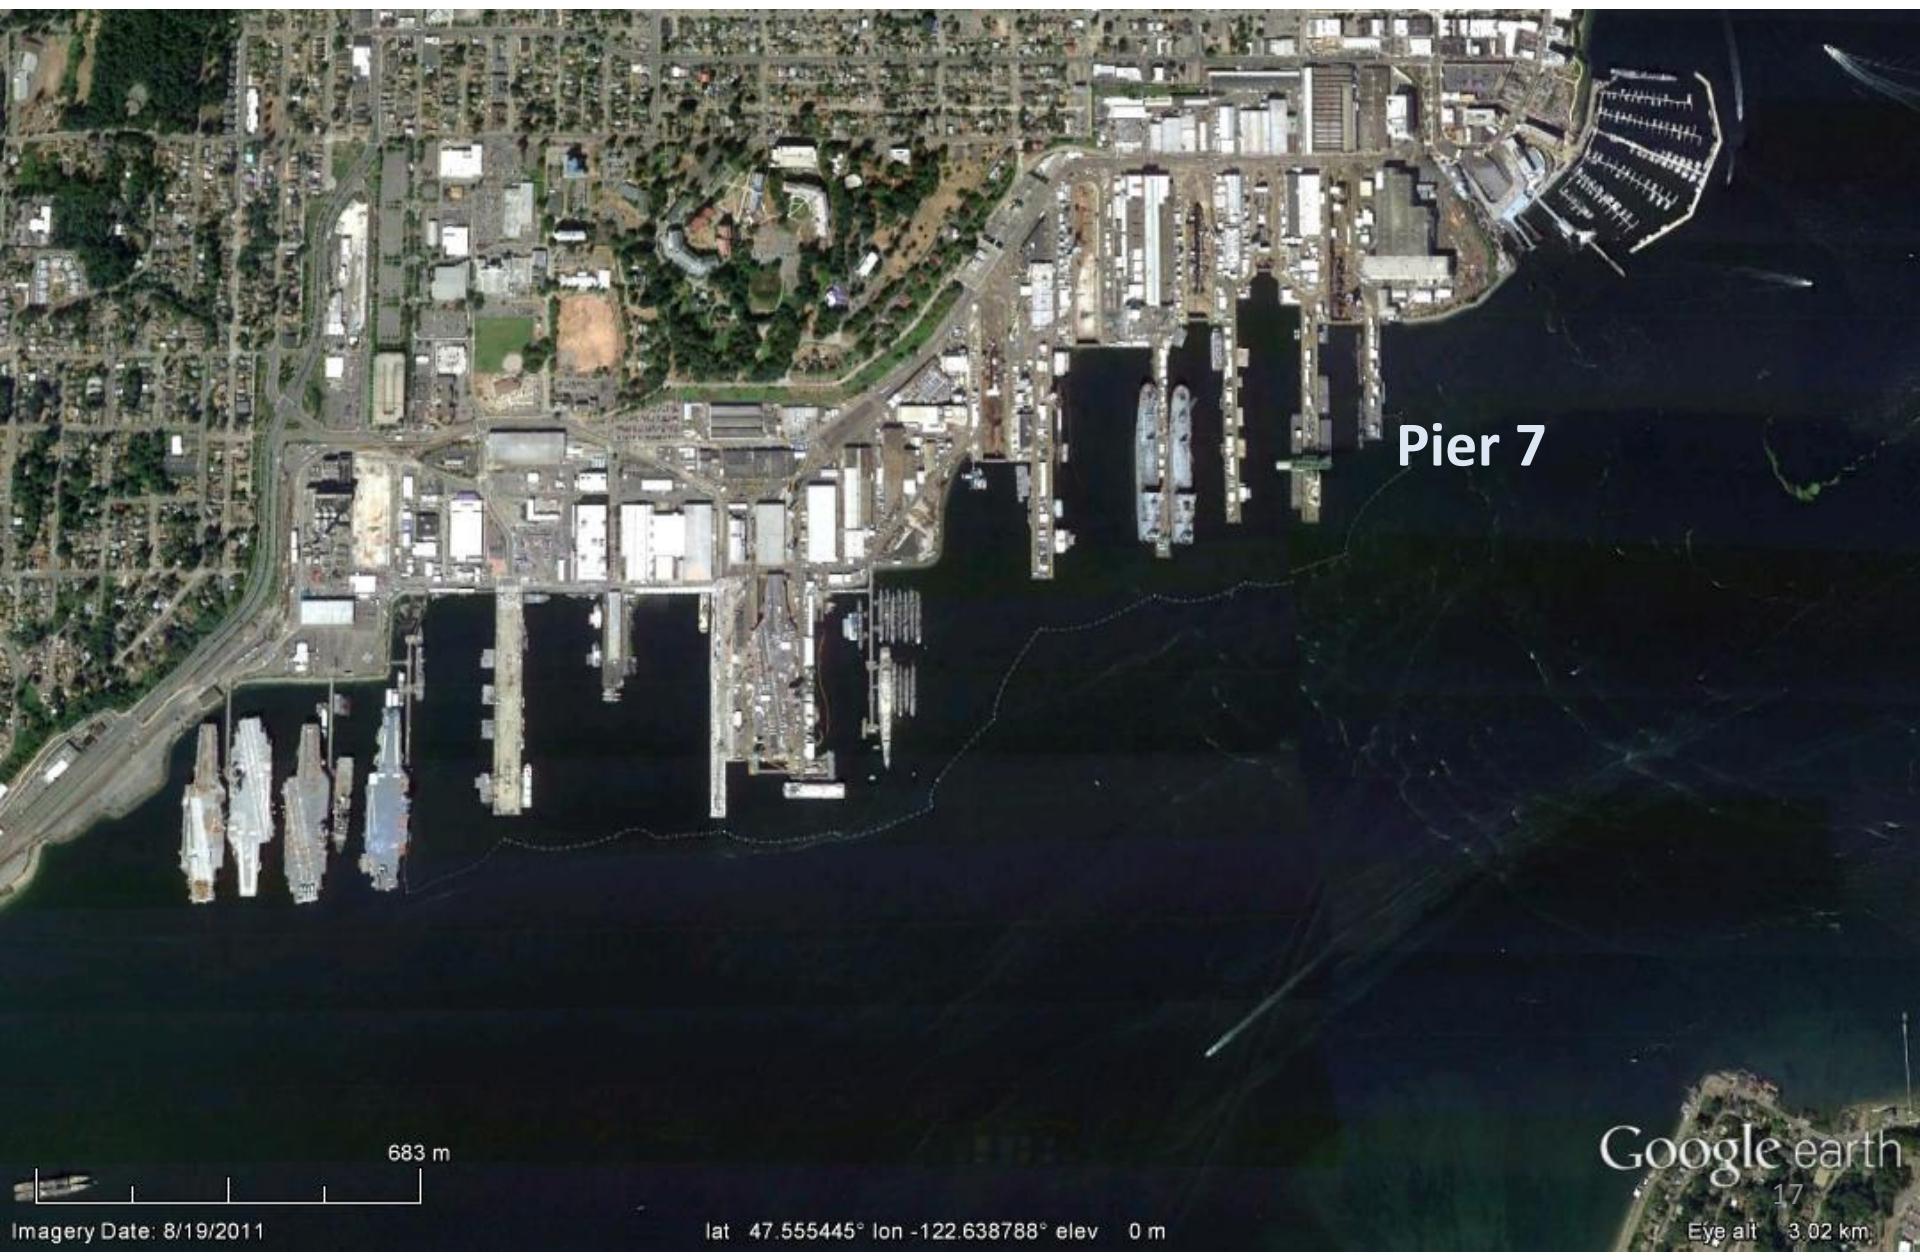
Pier 7 Site Location

Legacy sediment contamination found during fender pile replacement project in 2010

Contamination elevated above State Cleanup Standards for:

- **Polychlorinated Biphenyls (PCBs) (risk driver for sediment remediation)**
- Mercury (Hg)
- Other Metals (Copper, Zinc)

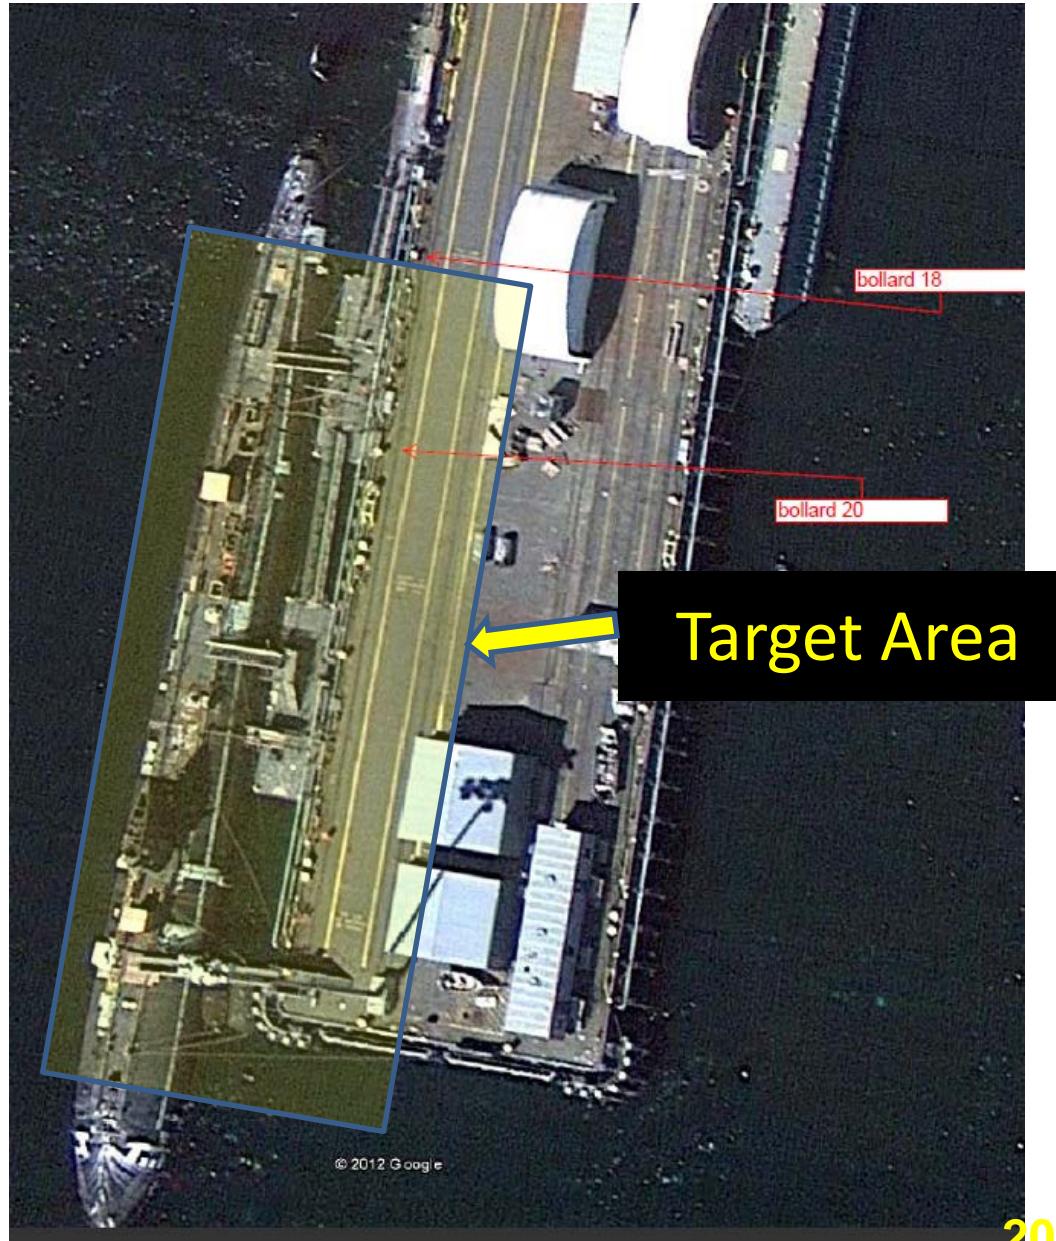
Pier 7 Amended Cap Demonstration Project

- 2011 Laboratory Evaluation Study
Results Support **GO**
- 2012:
 - Aug 1-17 Pre-Placement Monitoring
(Baseline)
 - Oct 15-19 Placement
 - Oct 30-31 Placement Verification
(T=0.5 month)
- 2013
 - Jan (**T=3 month**) Monitoring
 - Aug (**T=10 month**) Monitoring
- 2014
 - July (**T=22 month**) Monitoring
- 2015
 - July (**T=34 month**) Monitoring

Remedial Action under CERCLA as
part of the Record of Decision for
site clean up

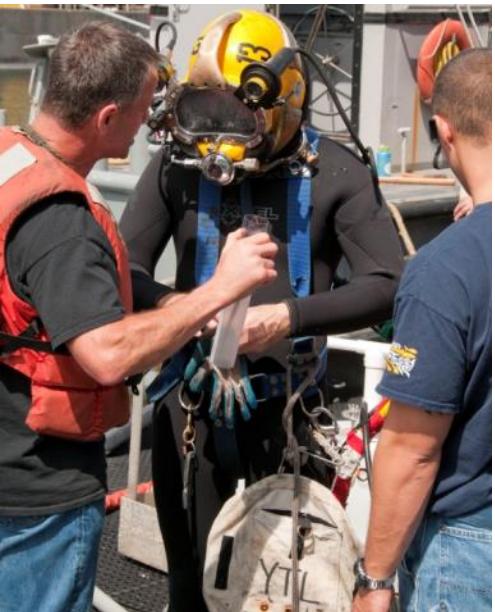
- SEA Ring Chambers Deployed at 10 stations for 14 Days
 - Bioaccumulation of PCBs and Hg
Clam – *Macoma nasuta*
 - Worm – *Nephtys caecoides*
 - Passive Sampler – solid phase micro extraction (SPME)
- Toxicity
Amphipod – *Eohaustorius estuaricus*
- Physical, chemical and biological characterization (including TOC/Black Carbon)
- Sediment Profile Imaging (SPI) Camera at ~ 50 locations, extending beyond target footprint

- Amendment Target Area
- SPI Monitoring
- SEA Ring Chamber
- ▲ Reference Site

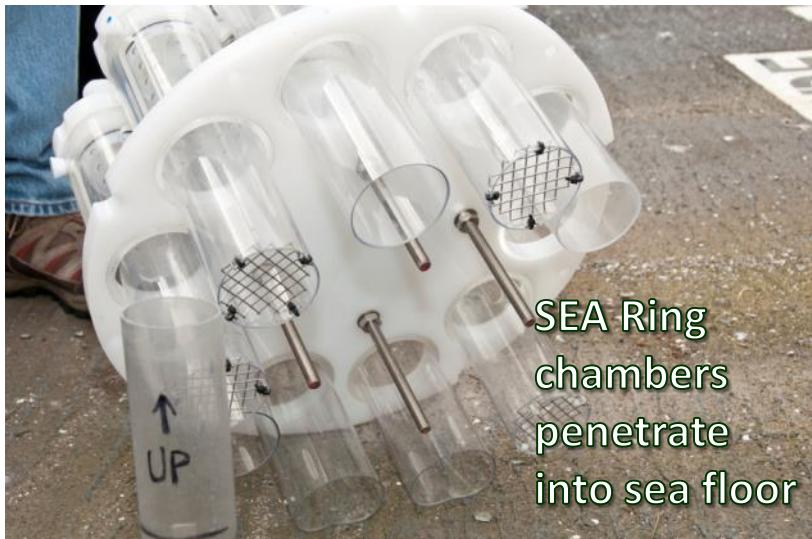
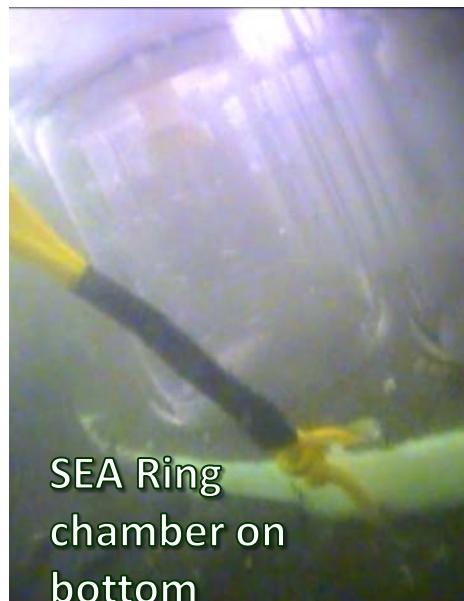
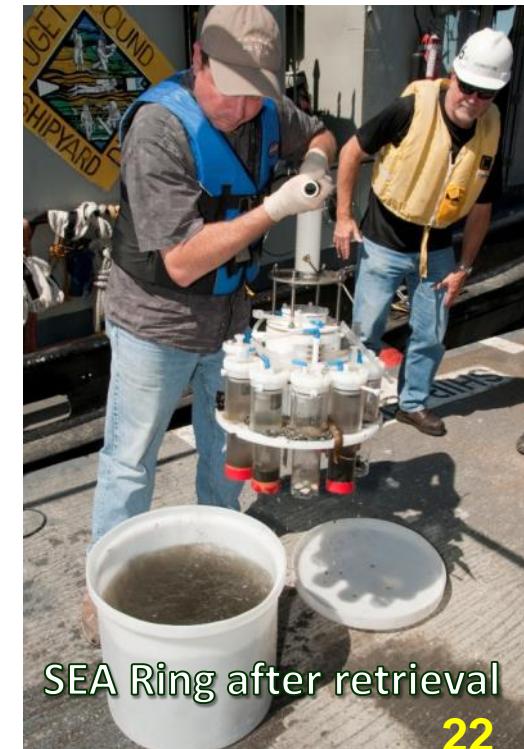
Preparing SEA Ring

Water Quality and Passive Samplers

Worms and Clams

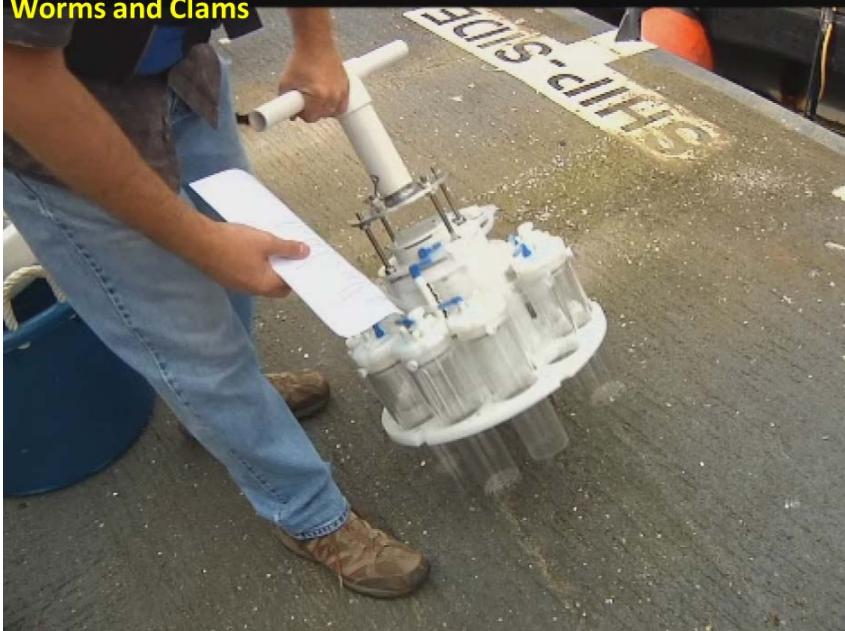
Recovering SEA Ring

Worms, clams, benthic community

Passive samplers

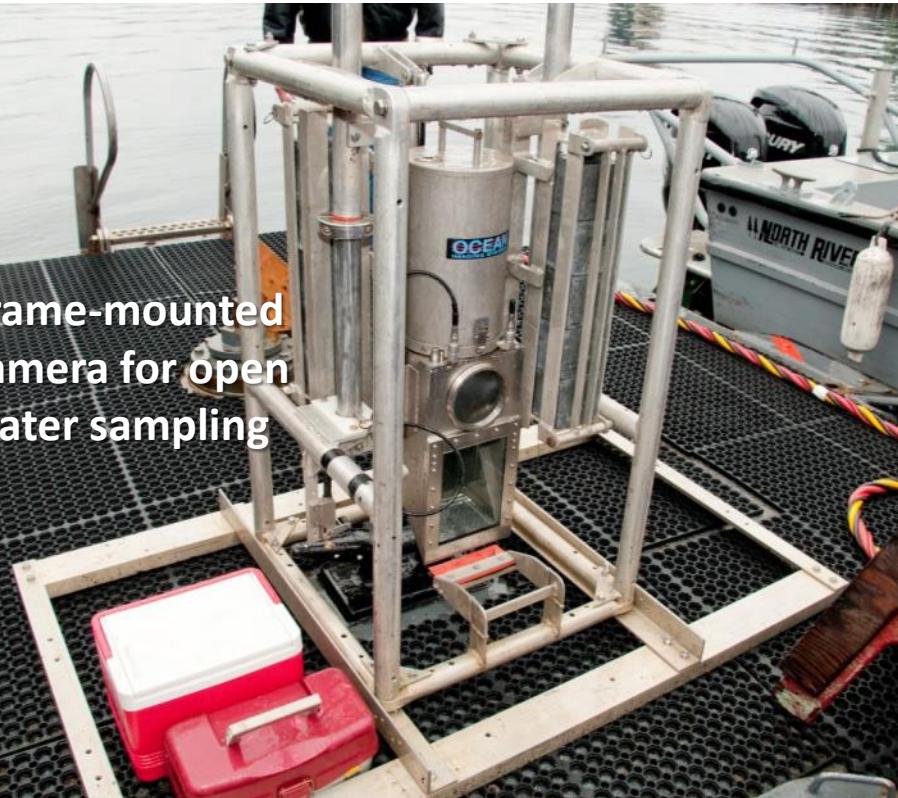
Frame-mounted
camera for open
water sampling

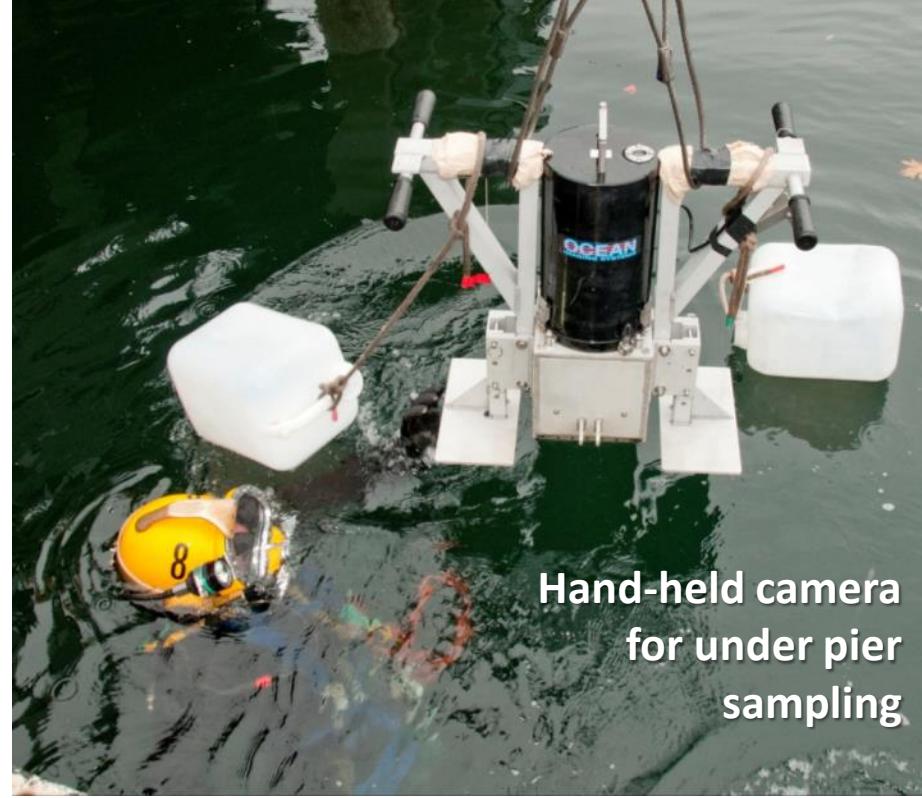
Hand-held camera
for under pier
sampling

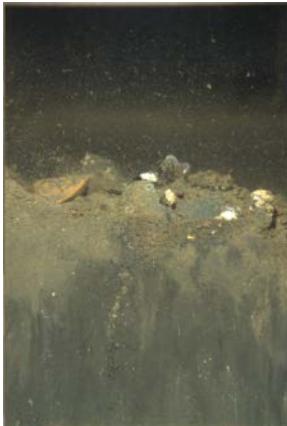
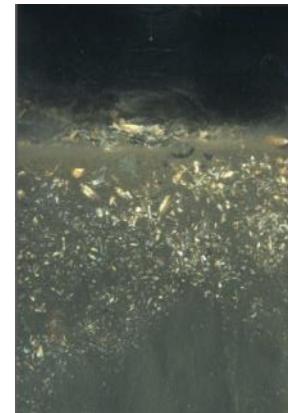
Sediment Profile Images

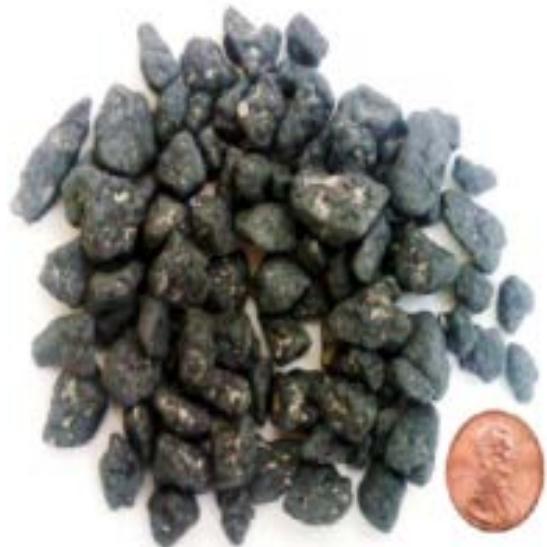
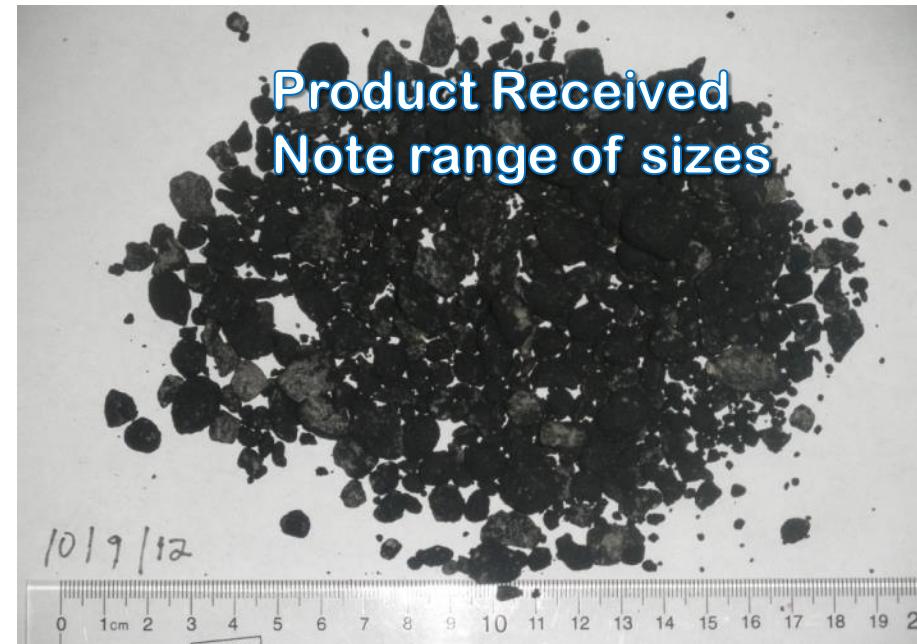
AquaGate+PAC™ Composite Aggregate

Dry State – Pre-Placement

Coating Layer

Aggregate Core:
Average Size
1/4 - 3/8"

Post-Placement

After Placement – Powder Activated
Carbon Falls off Core and Mixes
Naturally with Sediment

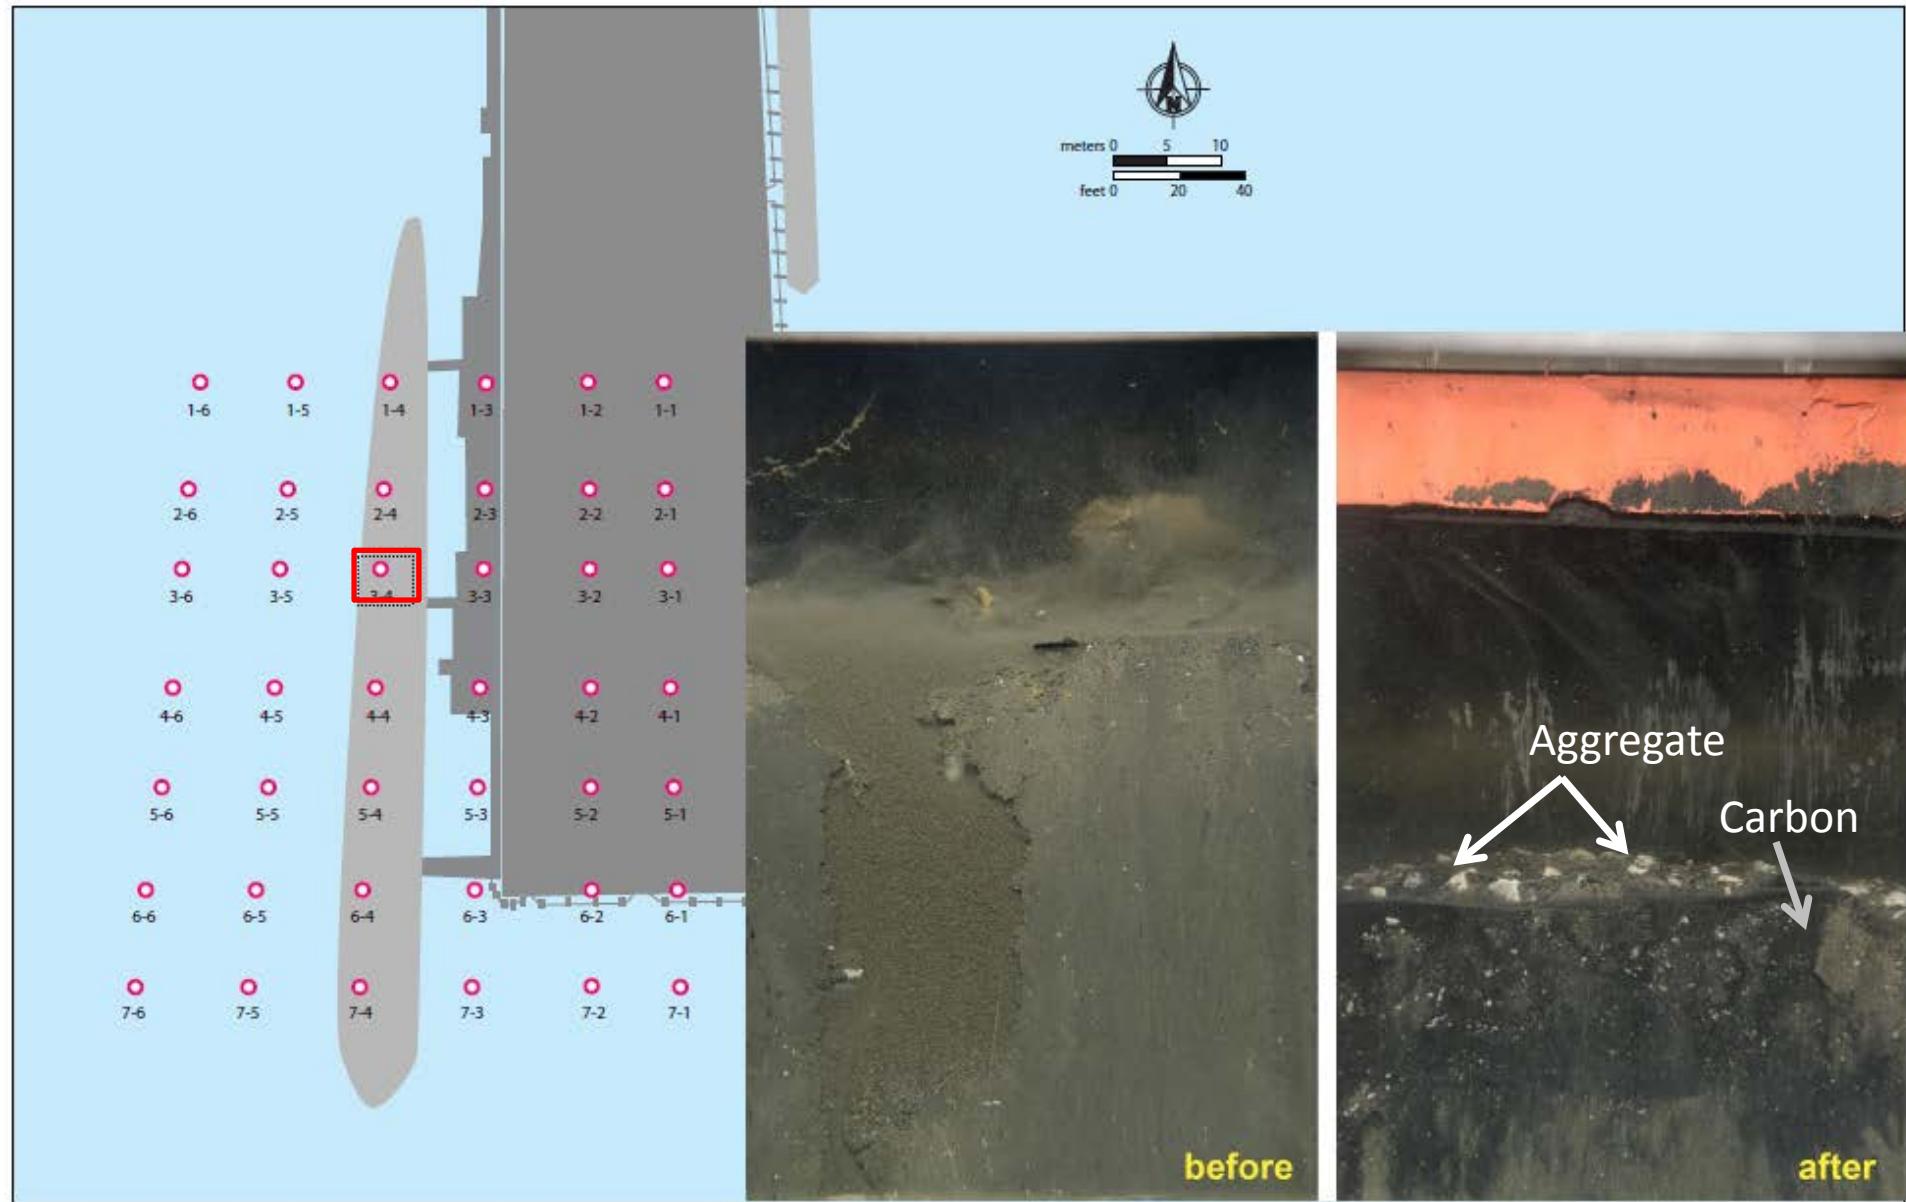
Sediment Profile from SPI camera

Average Activated Amendment Cap Layer Thickness (cm)

- area with detectable thickness
- area with a trace

Thickness of Amendment Cap Following Placement Oct 2013 (T=0.5 month)

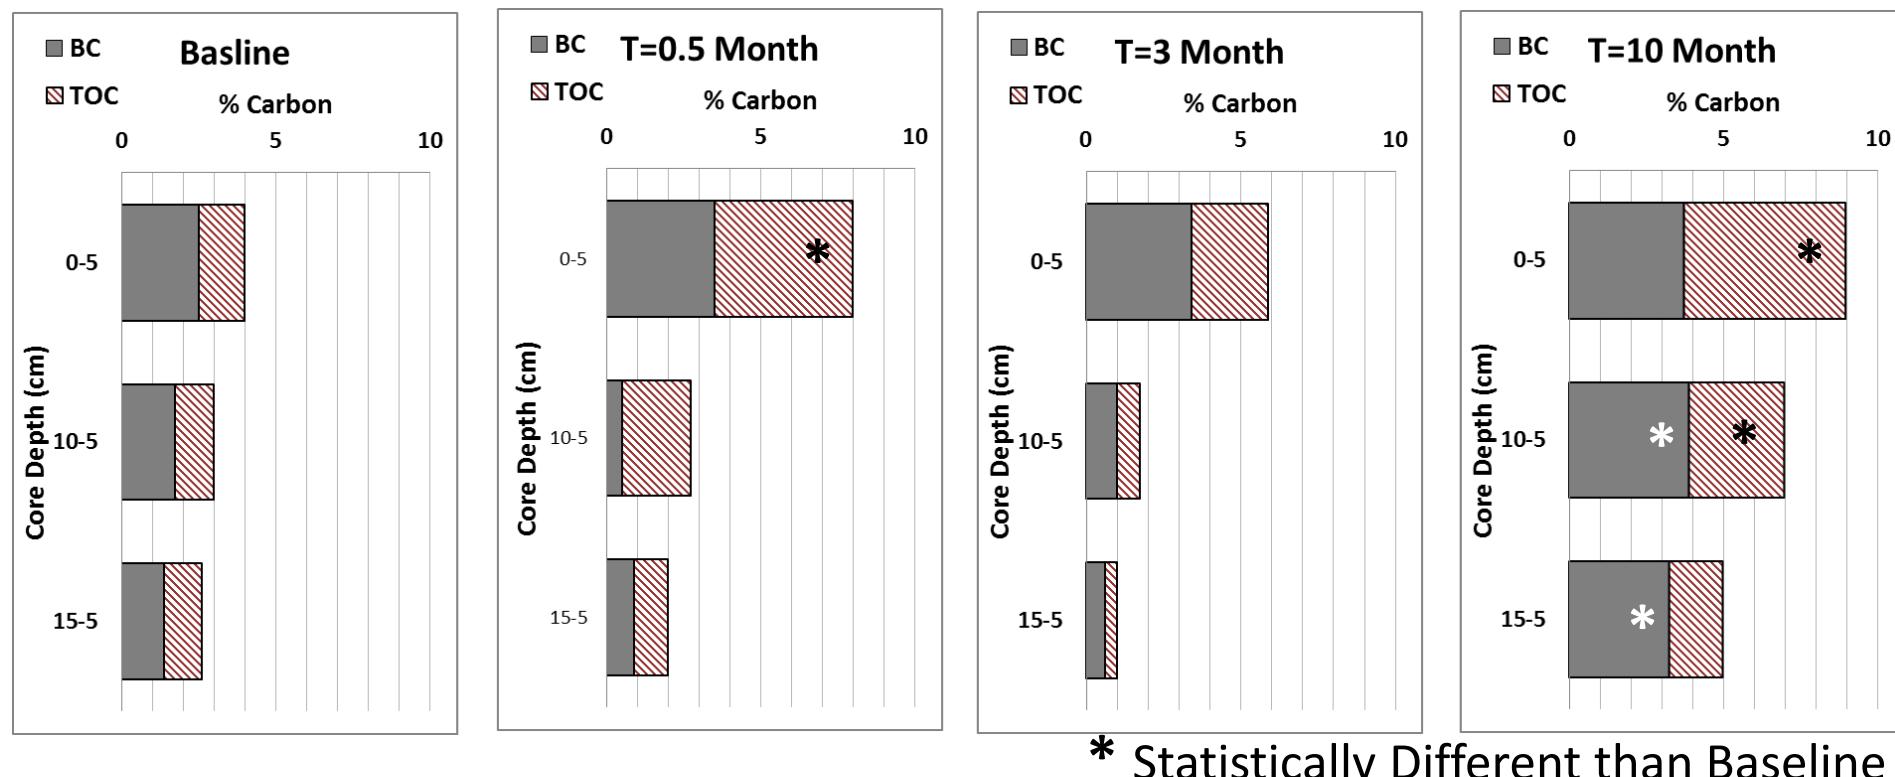
Average Black Carbon (BC) and Total Organic Carbon (TOC) measured in Sediment Cores

* Statistically Different than Baseline

- Measurements confirm increase in carbon content in sediment
 - Expected increase in carbon following installation; ~2x increase in surficial (0-5 cm) layers from 4% to 8% TOC.
 - At 10-mo there appears to be an increase in carbon at deeper levels.
 - Variability across site; look at trends not mass balance.
 - Further investigation into sample processing and analysis methods to address bias.
