Results from the West Sound Mussel Watch Monitoring and Effectiveness Monitoring of an Activated Carbon Sediment Amendment at a Contaminated Site

Presentation for West Sound Science Seminar
Poulsbo, WA, March 5, 2015

Monitoring the effectiveness of an activated carbon sediment amendment at a contaminated site located at the Puget Sound Naval Shipyard & Intermediate Maintenance Facility (PSNS&IMF), Bremerton, WA

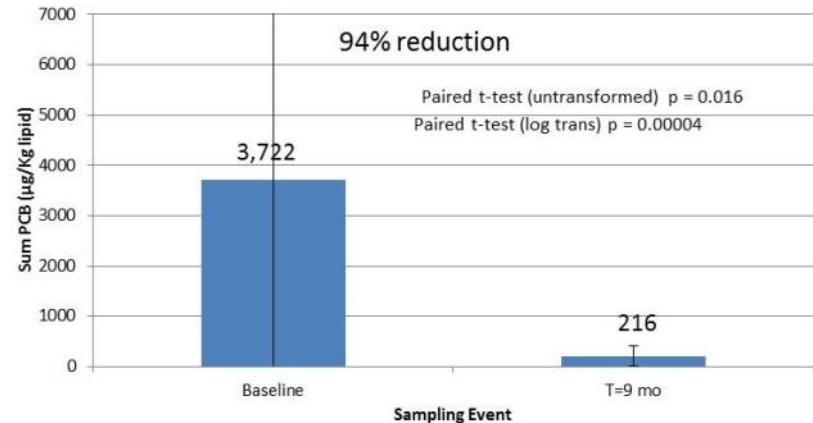
Sum PCB Bioaccumulation (all data, lipid norm)

Baseline and T=10 months (n=24)

Significant reduction (~90%) in PCB bioavailability to sediment invertebrates

- Concurrence with 90% reduction observed in the initial lab study.
- Sum of detected PCB congeners for all organisms used in bioaccumulation exposures during Baseline and T=10-mo post-remedy.
- Paired t-tests showed highly significant differences between baseline and post-remedy.
- Reduction in PCB bioaccumulation was apparent in both species: *Macoma nasuta* and *Nephtys caecoides*.
- Reduction in PCB bioaccumulation consistent across stations.

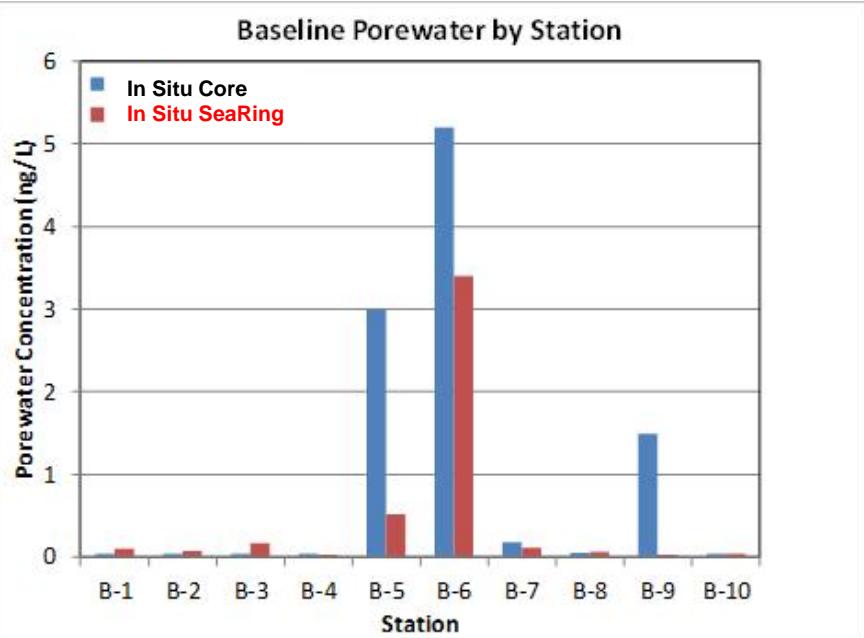
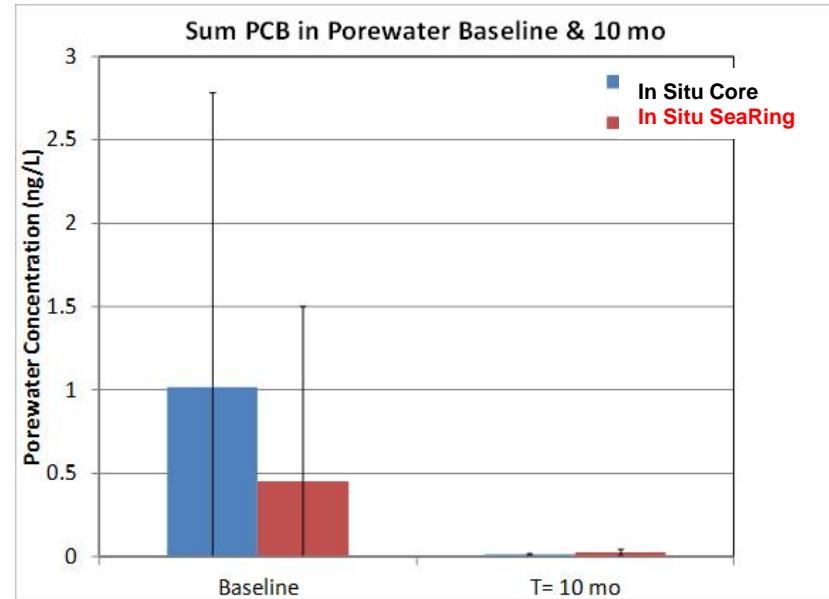
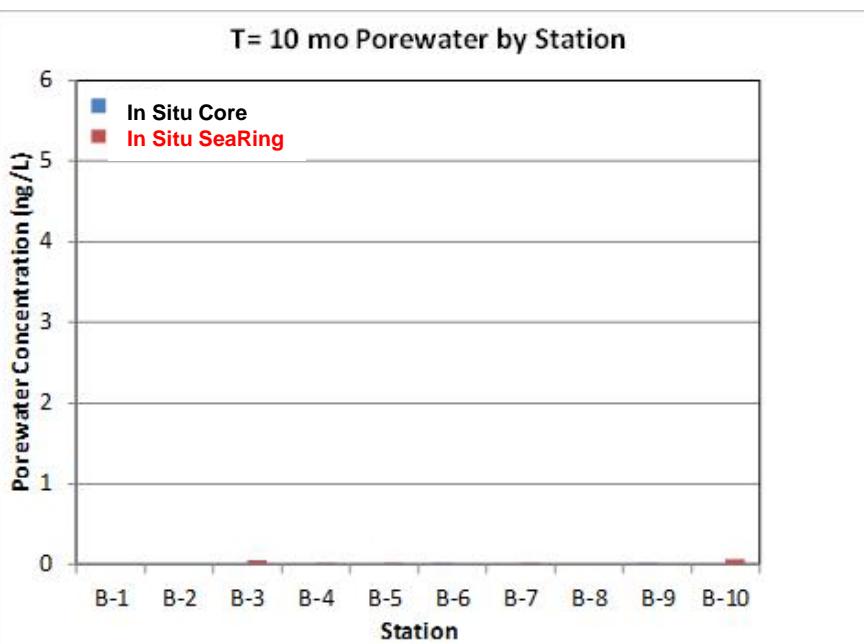
PCBs in Porewater Measured by Passive Samplers

- **Similar reduction (~95-99%) in PCBs in porewater as observed in invertebrate tissues**
 - Concurrence with reduction observed in the initial lab study.
 - Sum of detected PCB congeners for both SPME exposures (in situ SeaRing and in situ cores) used during Baseline and T=10-mo post-remedy.
 - 99% and 95% reduction in mean based on SeaRing and Cores, respectively.
 - Reduction in PCB levels in porewater was apparent in both in-situ (SEA Ring) exposures and lab core exposures.
 - Reduction in PCBs in porewater was consistent across stations.

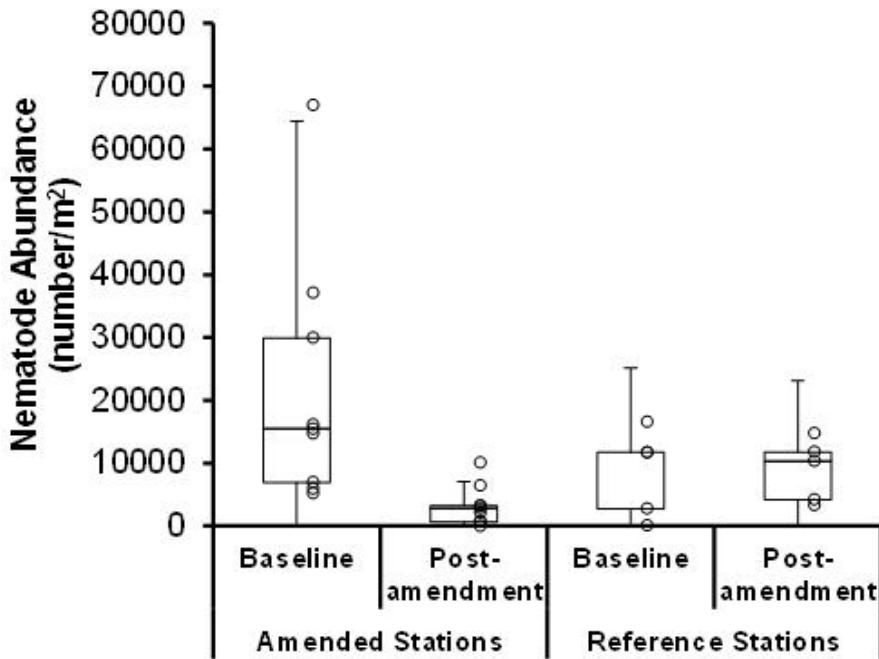
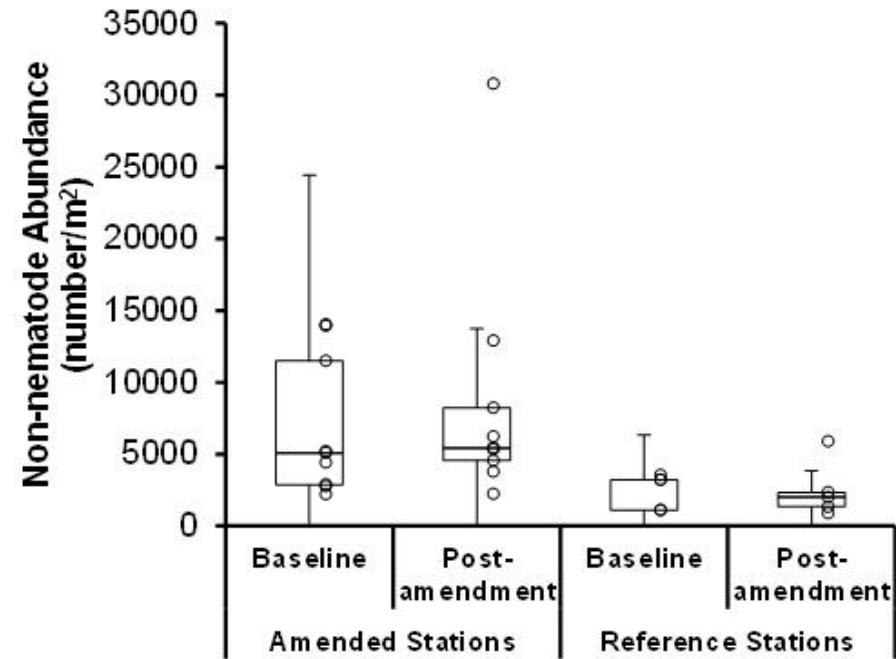
Benthic Census Evaluation (Tracking Purposes Only)

Slight shifts in community structure observed

- Abundance at the amended stations decreased between baseline and 10-month (post-amendment) surveys, but was driven by nematode abundance decreases.
- Abundance of non-nematode invertebrates at the amended stations was comparable to that of the reference stations.

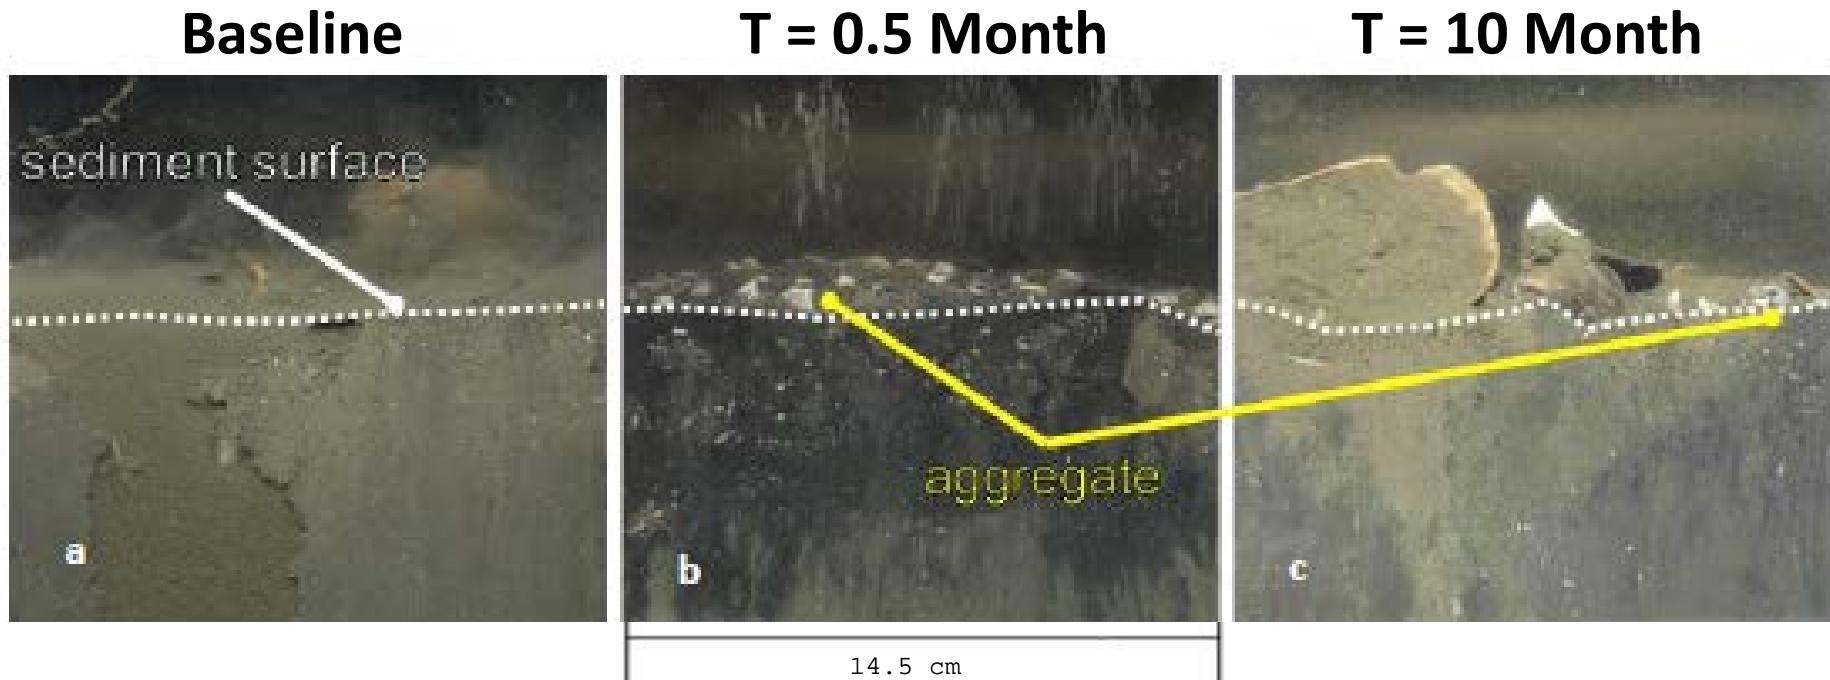
Sediment Profile Images at a Representative Site

- AquaGate + PACTM particles on sea bottom
- Activated Carbon released from carrier granules
- At 10 months Activated Carbon was being reworked into underlying sediment
